Installation Troubleshooting Guide for Standard Steel Doors and Frames

SDI-122 Installation Troubleshooting Guide for Standard Steel Doors and Frames

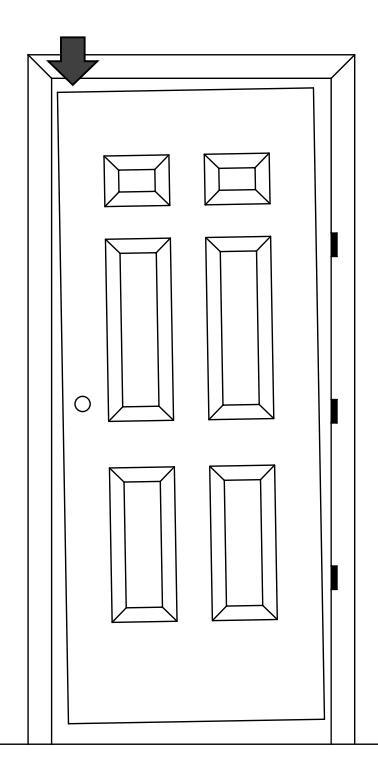
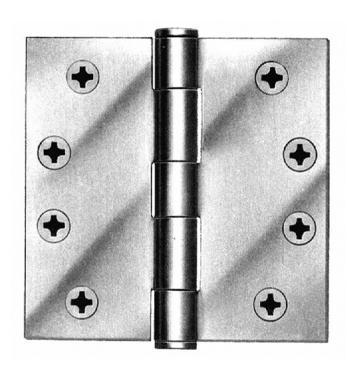
Is door sagging?

Uneven clearances frequently result from improper installation of frames and frame anchors. The condition, characterized by lock edge clearances narrow at the top and wide at the bottom, is called "door sag." The following suggested adjustments may correct the condition.

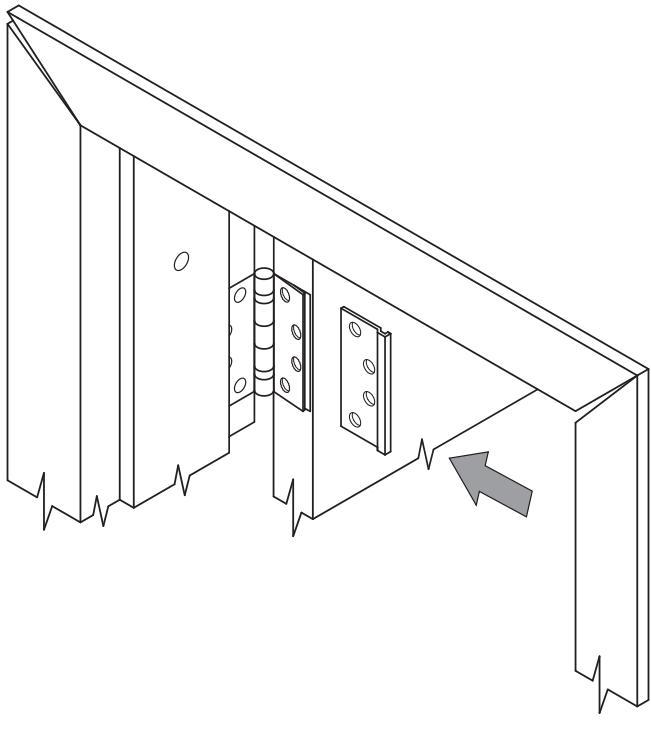
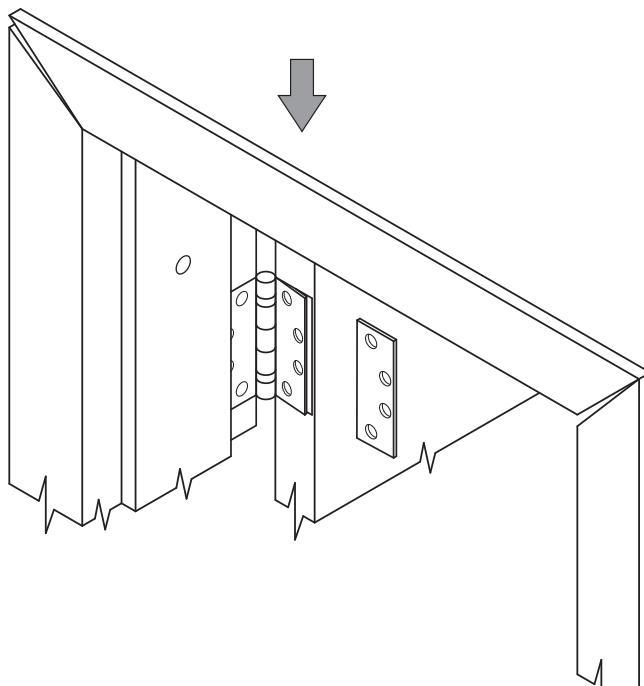
Remove top hinge filler for nonhanded doors

The improper clearance condition may be improved by removing the top hinge leaf attached to the door and taking out the filler (hinge filler) from behind the leaf. Once completed, reattach hinge leaf to door. A hinge filler is used on all non-handed doors.

Add shims to bottom and/or middle hinge

On handed or non-handed doors, the lower half of the door can be shifted upward and toward the strike jamb. Remove the screws which attach the middle and/or bottom hinge(s) to the door. Insert shims between the hinge leaf and door. Reattach hinge leaf to door.

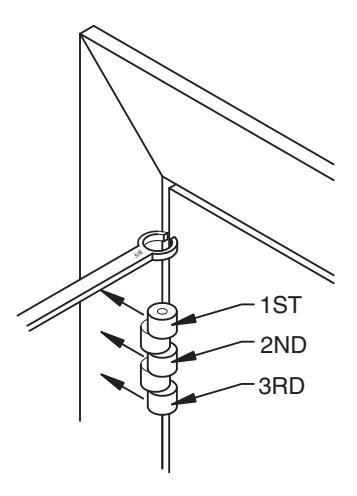
4. Reswage and align hinge knuckles.

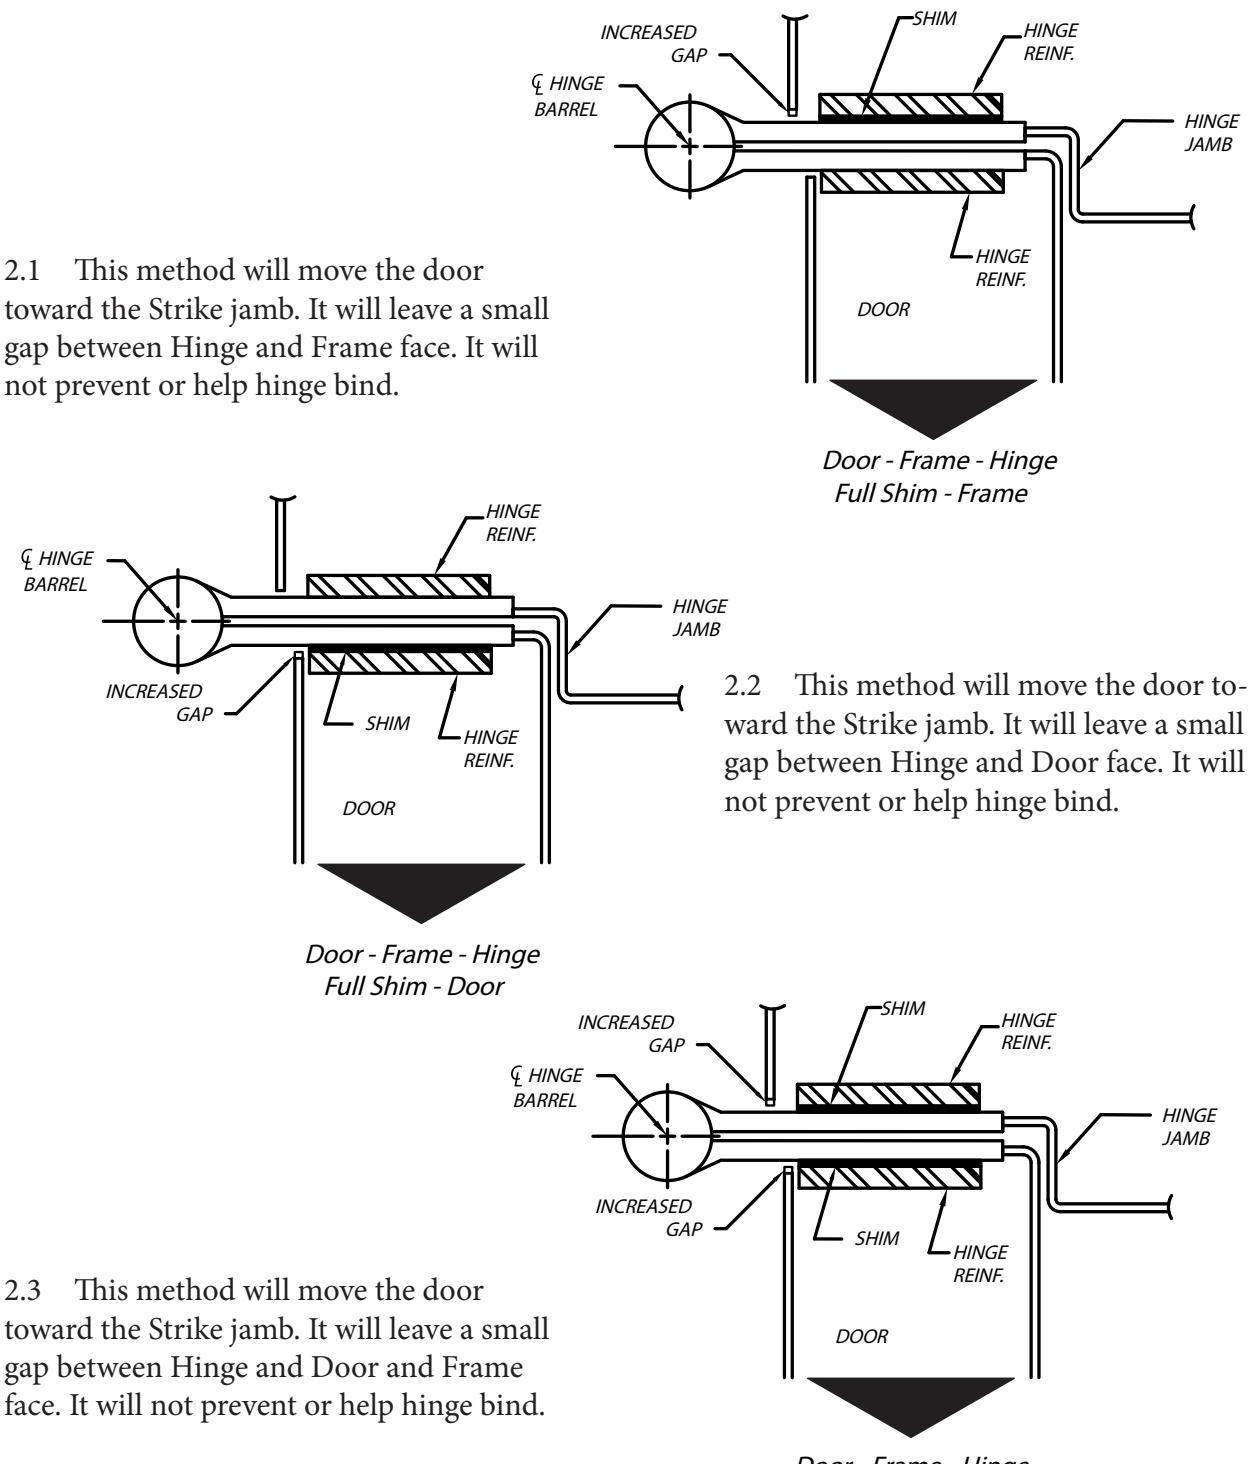
Door - Frame - Hinge Full Shims - Door & Frame

DOOR BIND AGAINST RABBET

Normally, door bind is found between the door and rabbet. There are several ways of shimming which will move the door in different directions. The following guidelines should be used in shim applications.

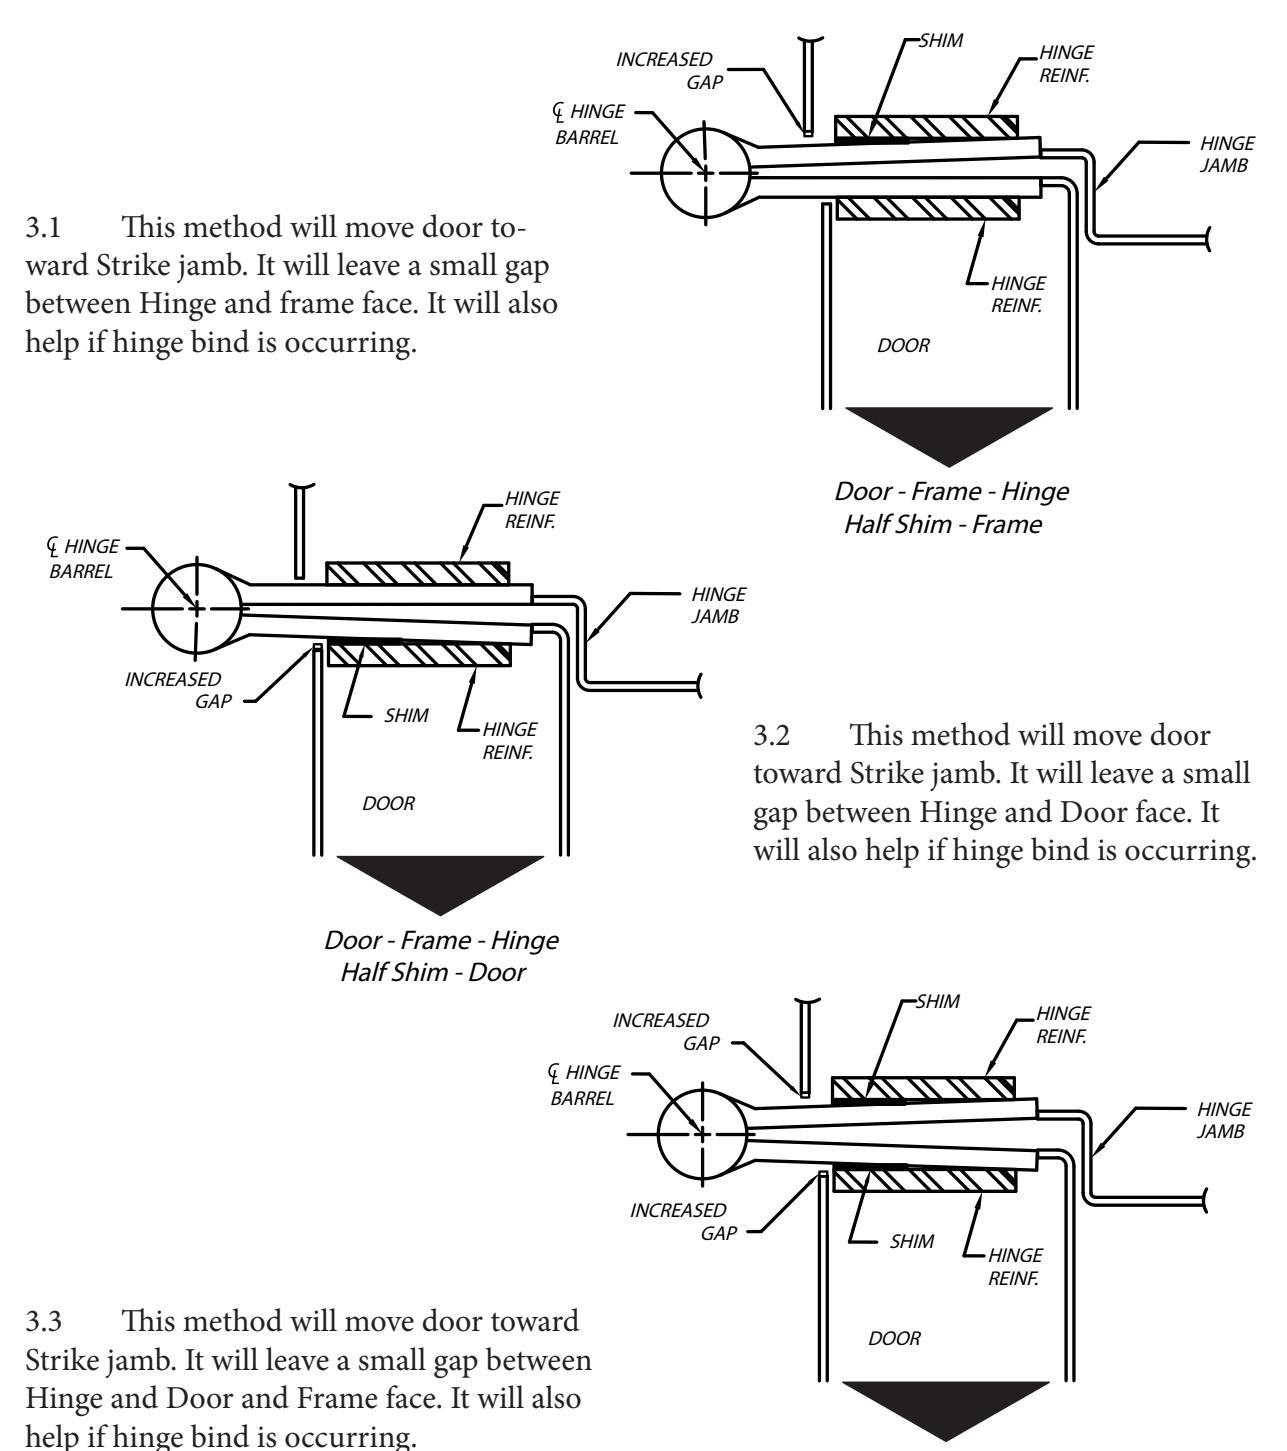
Door - Frame - Hinge Half Shims - Door & Frame

HINGE BIND AGAINST STOPS

Hinge bind against the frame stops is possible field condition. There are several ways of shimming which will move the door in the desired direction. The following guideline should be used in shim application.

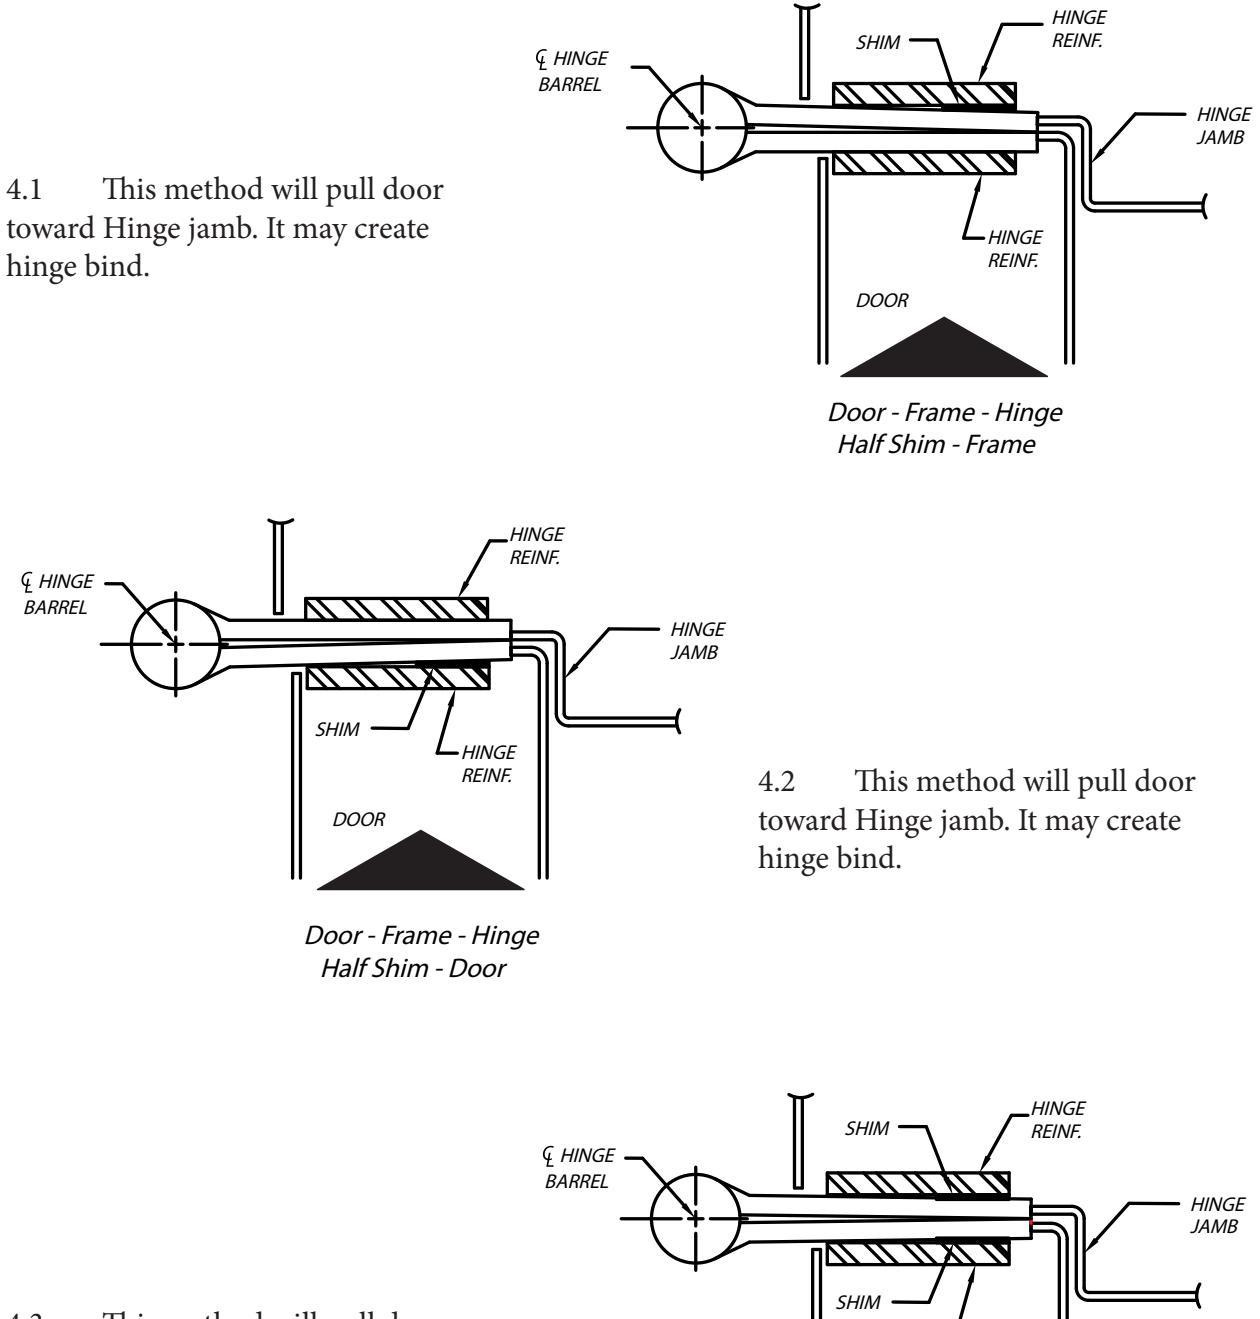
Door - Frame - Hinge Half Shims - Door & Frame

4.3 This method will pull door toward Hinge jamb. It may create hinge bind.

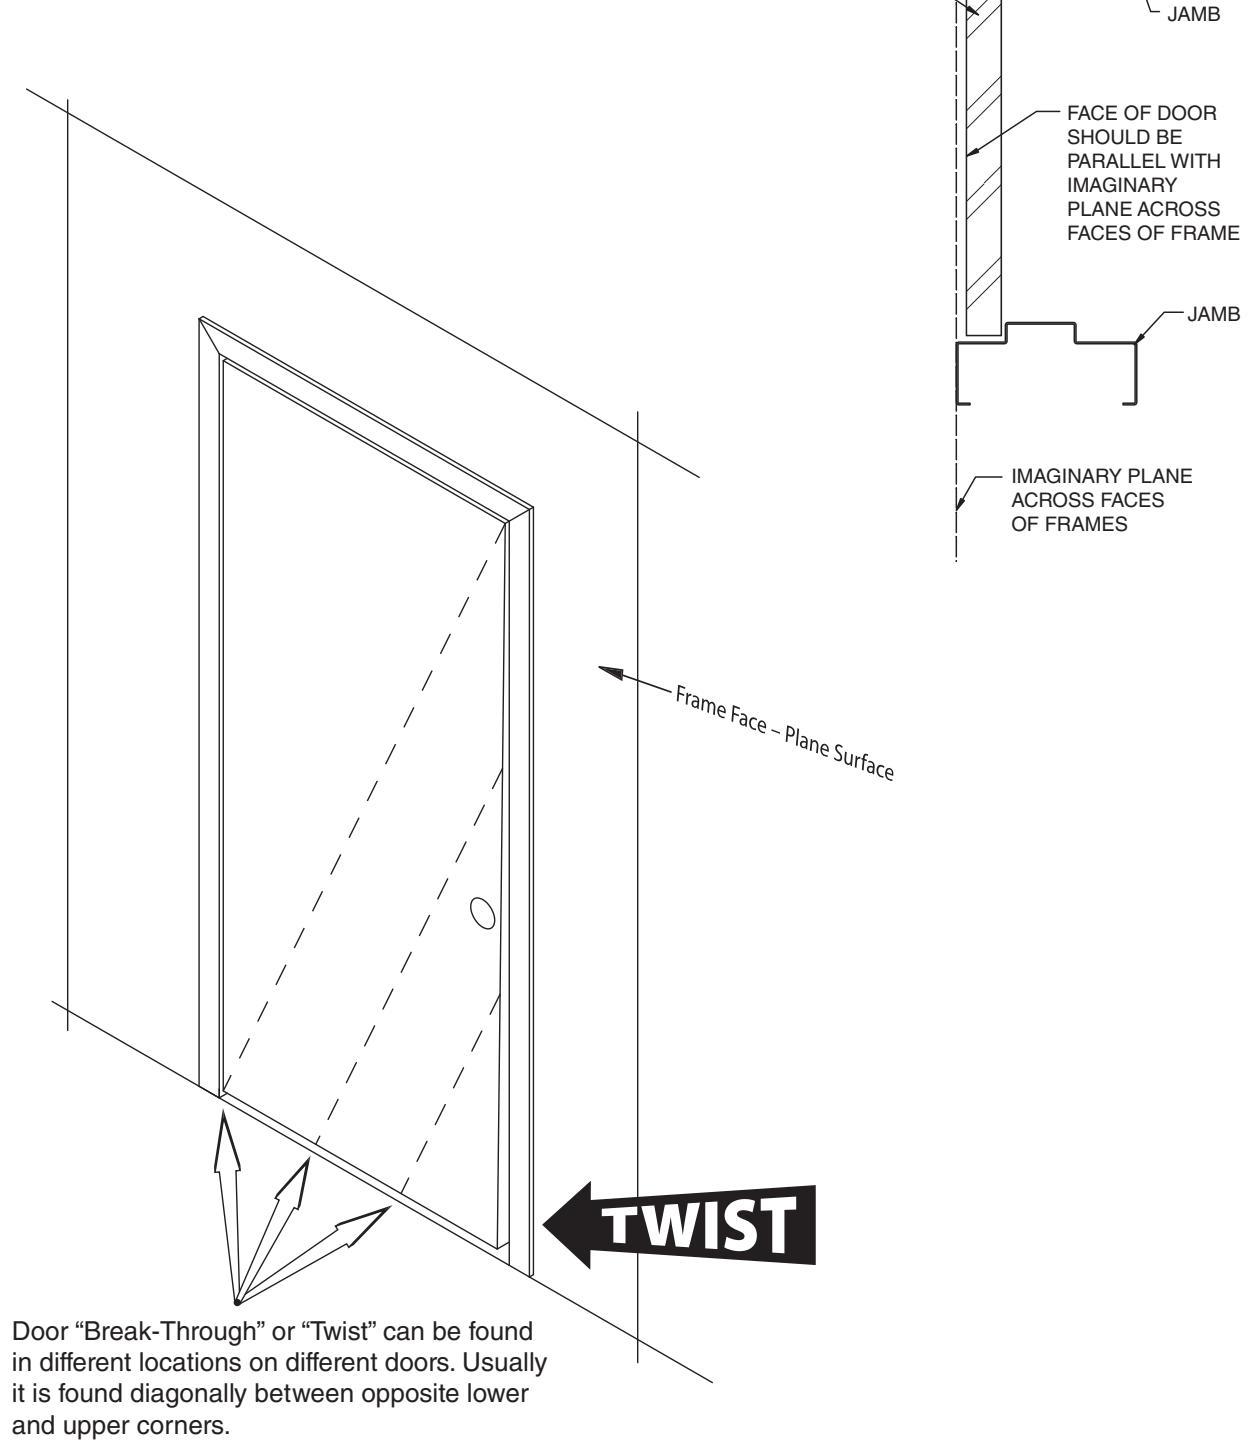
TWISTED DOOR

Normal installation results in the plane of the door face being parallel with the plane of the frame face. If the frame is square and plumb, all face surfaces of the frame will be in the same plane. A twisted door will "break through" the frame's face plane surface. **BE SURE** the frame is square and plumb. If it is not, the problem is probably with the frame installation and **NOT** the door.

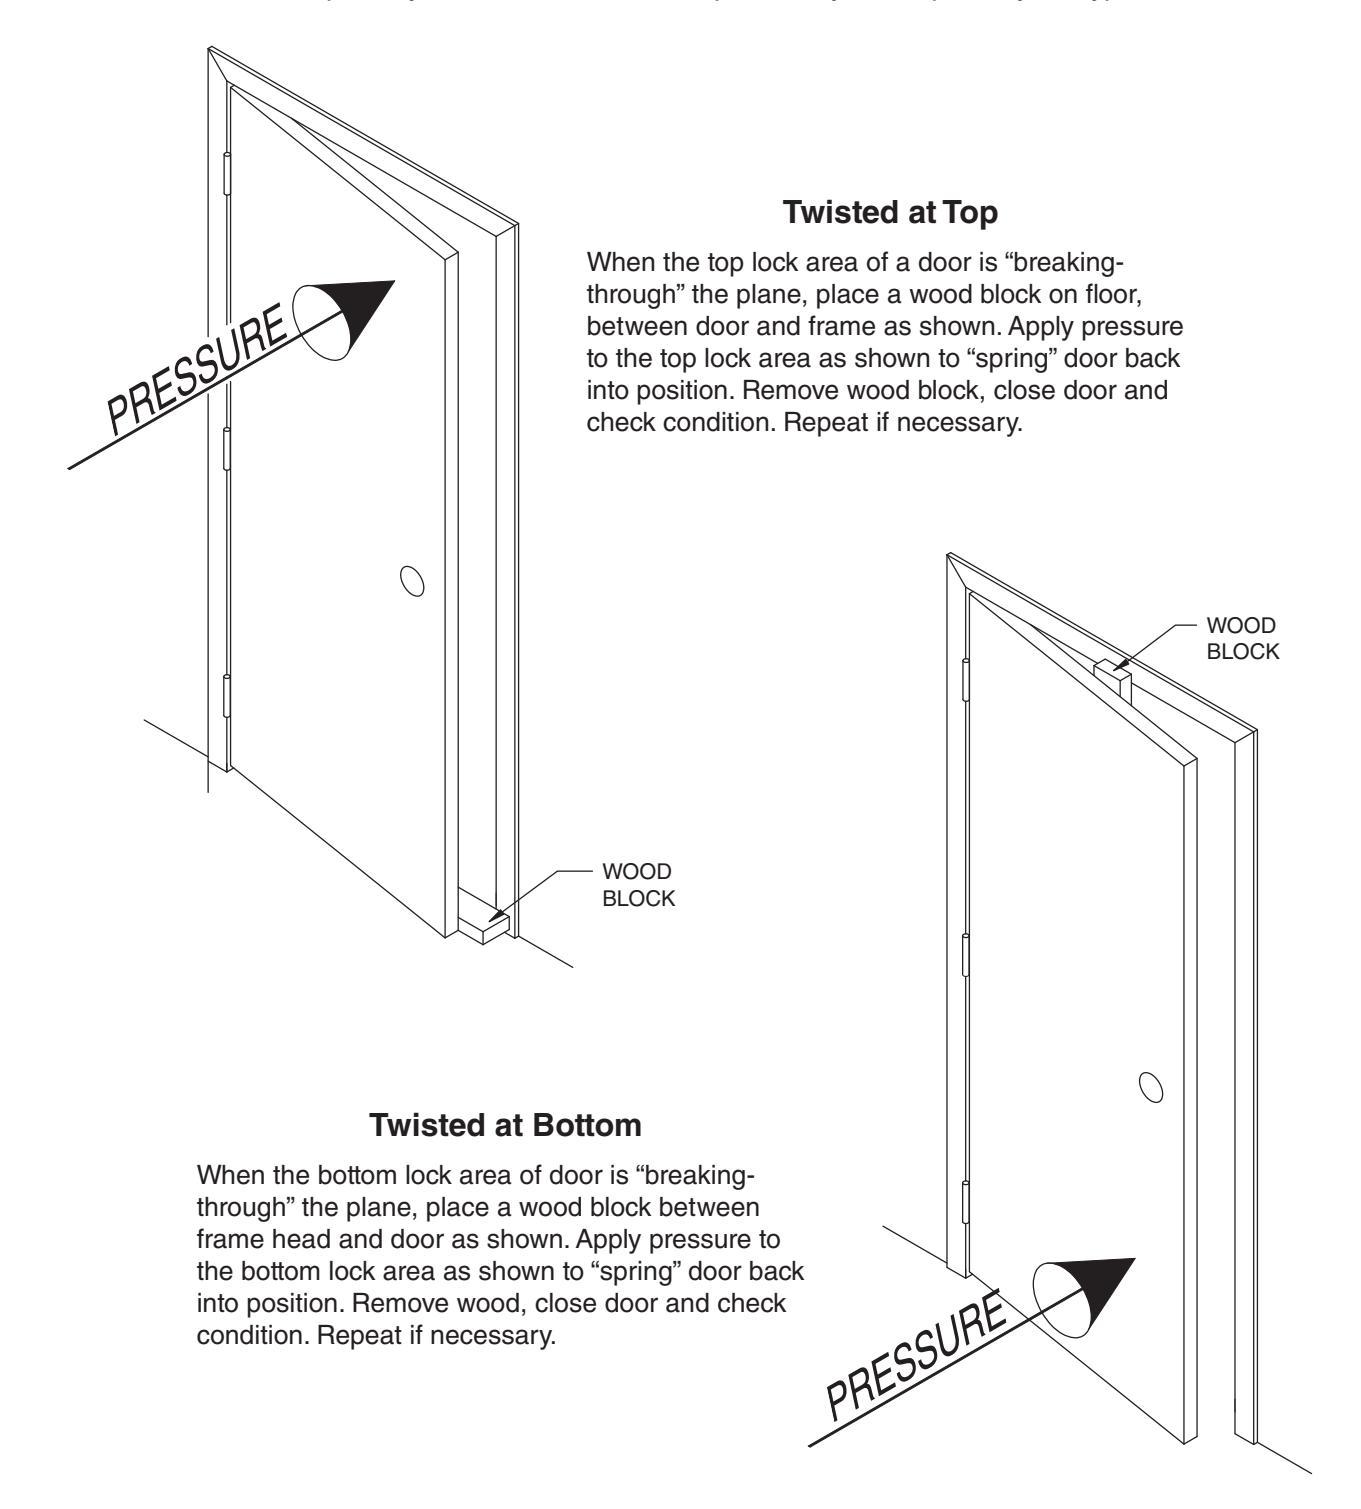
TWISTED DOOR ADJUSTMENTS

When required, it is possible to "spring" the door back to (or much closer to) its ideal position of being parallel with the plane across the faces of the frame. This can usually be done with the door remaining in the frame. A piece of wood blocking must be placed between the door and frame. Pressure is then applied at the twisted area to "spring" the door. However, caution should be exercised on drywall installations since the frame could possibly work lose from the wall, particularly with slip-on drywall type frames.

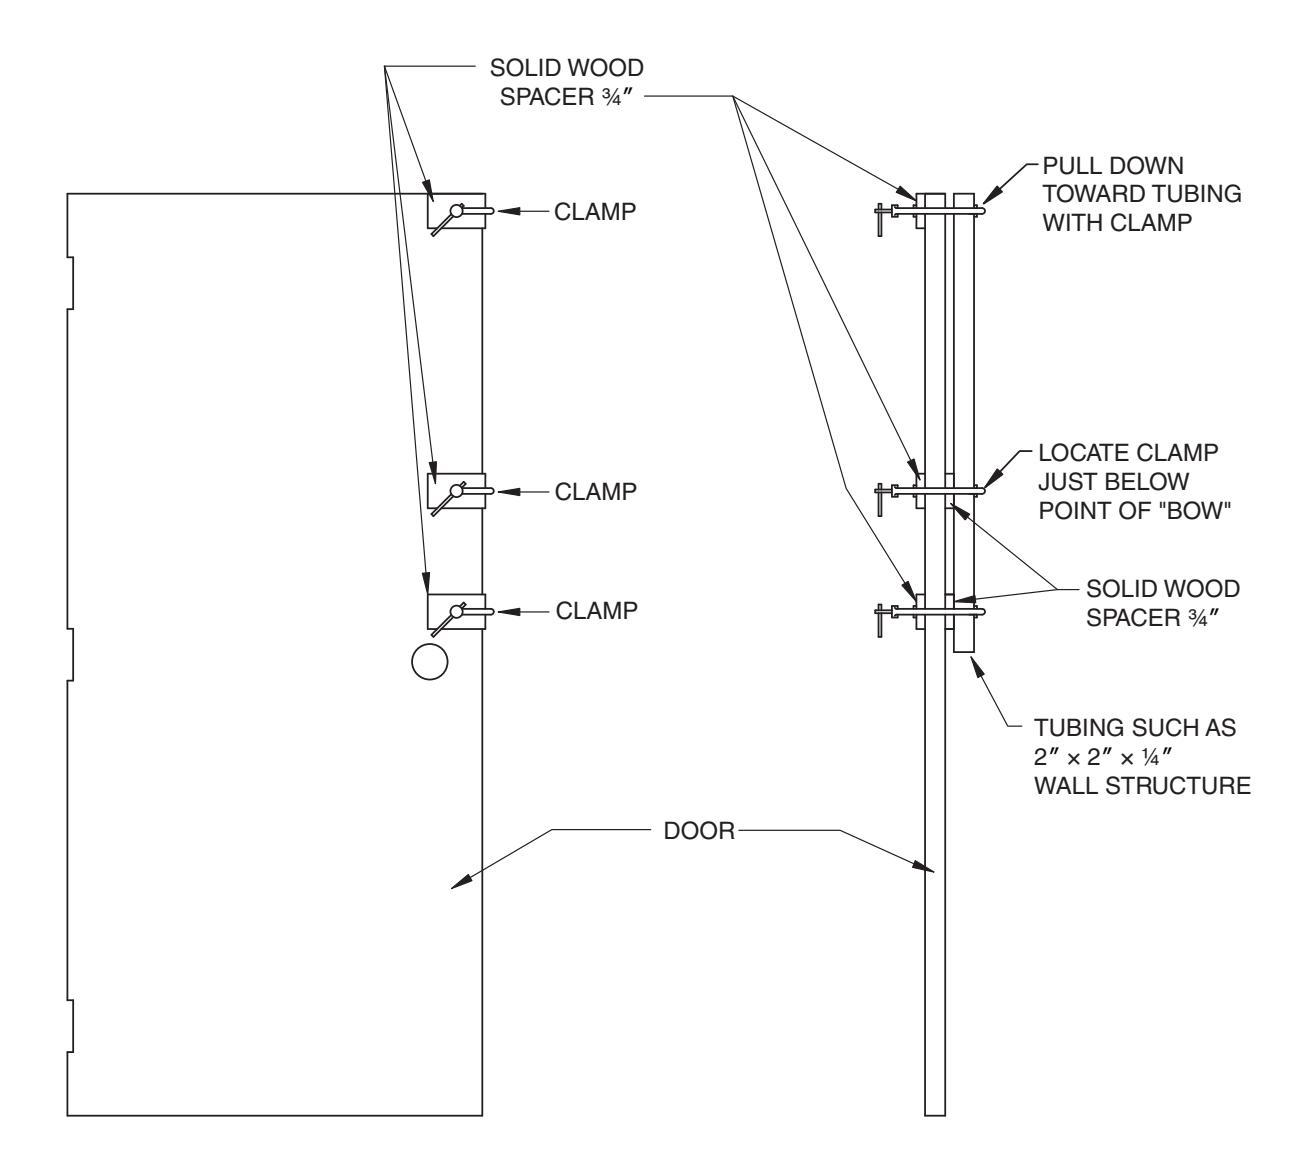
TWISTED DOOR ADJUSTMENTS (continued)

An alternate method can also be used which will allow the door to remain in the opening. This method might be appropriate in drywall installations as previously mentioned. Although the example shown deflects the top half of the door, this method could be used on the bottom half of the door as well.

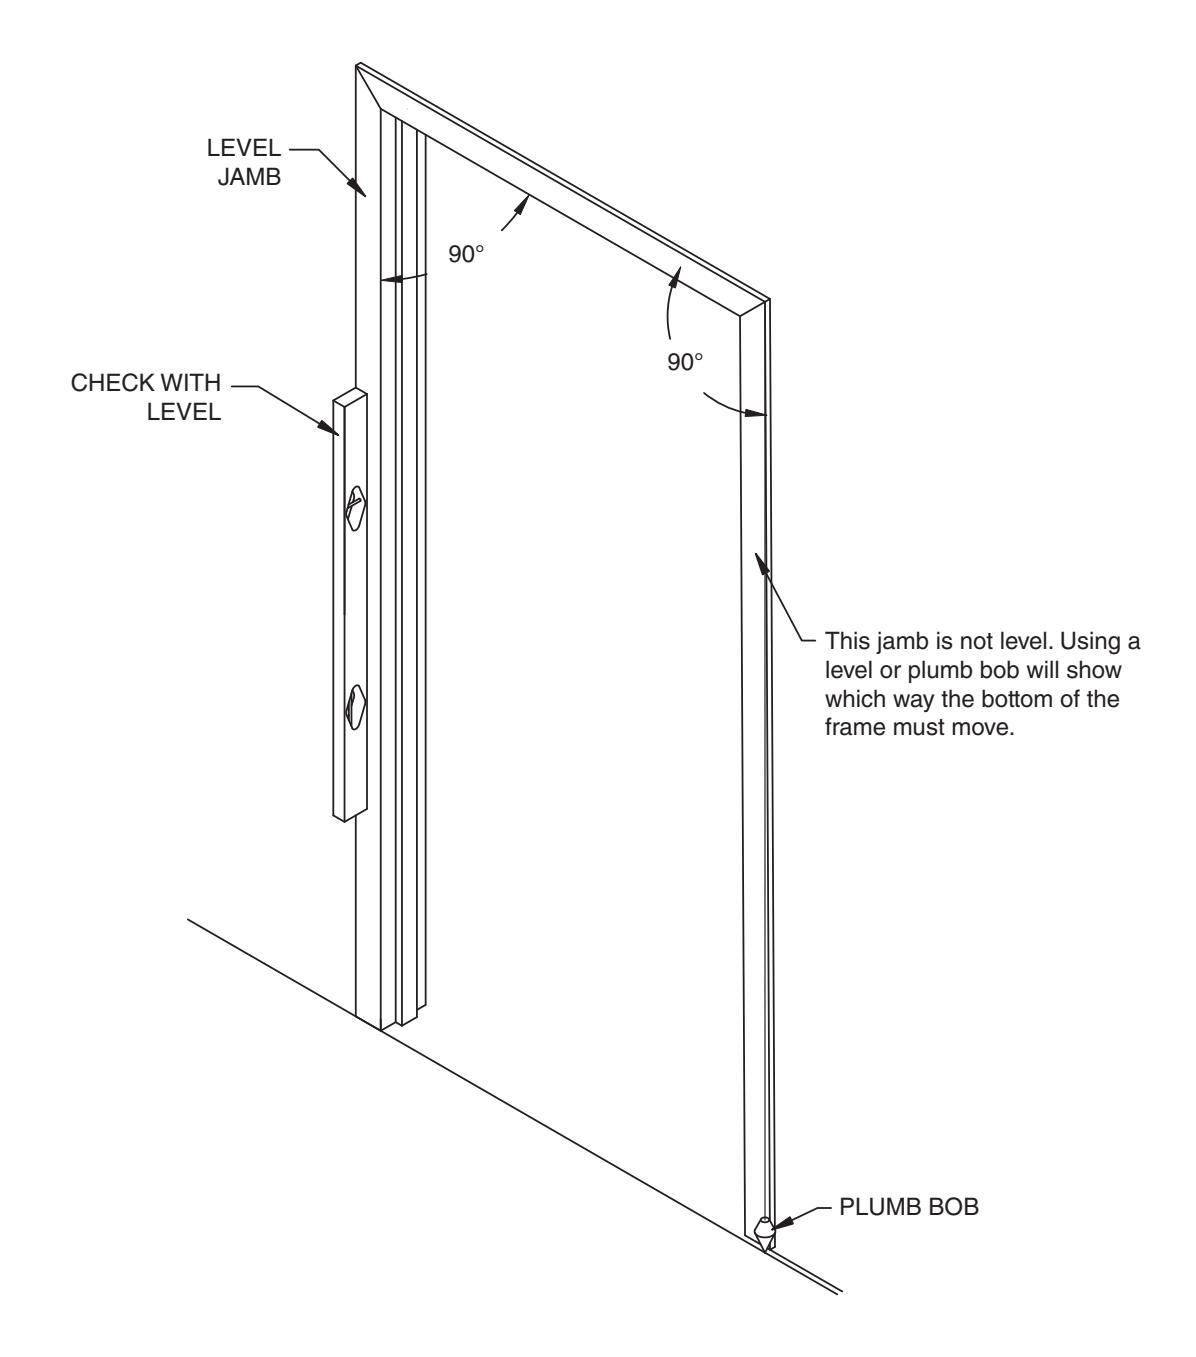
TWISTED FRAME

Wall conditions and anchoring methods can cause the frame to be "twisted" in the opening. The two jamb (hinge and strike) faces are not in the same plane as discussed in the twisted door section. This can be checked by using a level and/or plumb bob. Frames do not have adjustments when it comes to "twist".

The "twist" condition is generally caused by the wall conditions. The frame jamb faces are prevented from being set in the same plane because the walls are out of plane to begin with.

The options available to correct this problem depend, to a large extent, on the wall construction.

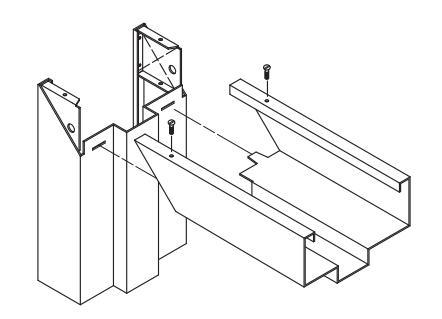
Corner Clip Header to jamb connection

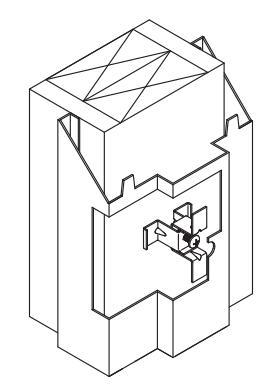
Compression Anchor (Cut-away view)

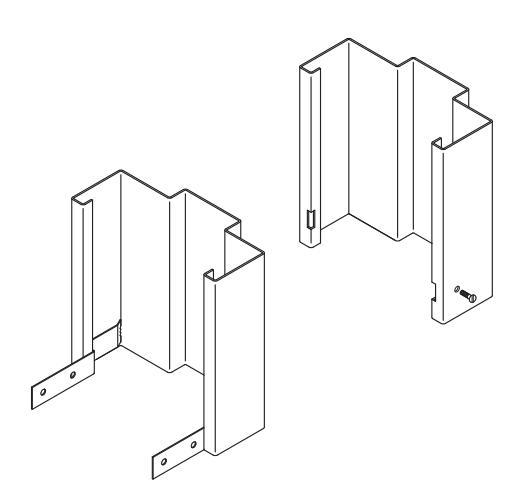
Sill Anchors Snap-in type or screw type

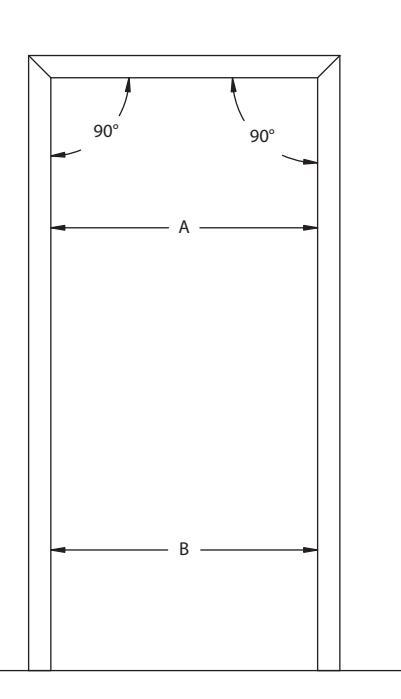
PROPERLY SET FRAME

All corners are 90°. The dimension taken at Point "A" is equal to the dimension checked at Point "B". Both hinge and strike jambs are plumb and level.

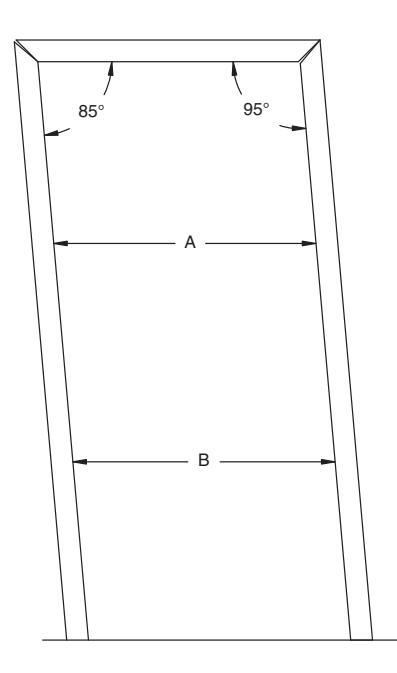
IMPROPERLY SET FRAME (A)

One corner is greater than 90° and one corner is less than 90°. The miters do not properly align with one another and "gaps" are created in the miters which are opposites of one another. The dimension taken at point "A" would remain the same when checked at point "B" if the 90° corners are out of square an equal number of degrees.

This condition can be corrected by adjusting the compression anchors in and/or out of each jamb as required. Loosen the corner clip screws if the frame is so equipped before making adjustments; retighten when finished. The compression anchors must be adjusted (turned) in opposite directions to allow the jambs to move.

For the illustration shown, the strike jamb compression anchor screw must be turned counterclockwise to retract the compression anchor and give room for the frame to be adjusted back into position using the hinge jamb compression anchor. The hinge jamb compression anchor screw is then turned clockwise to advance the anchor and push the frame towards the room made at the

strike jamb. The frame should be brought into square with the header and the hinge jamb compression anchor. Once this is done, the strike jamb compression anchor screw can be turned clockwise, advancing the anchor snug against the stud. The corner slip screws should then be retightened.

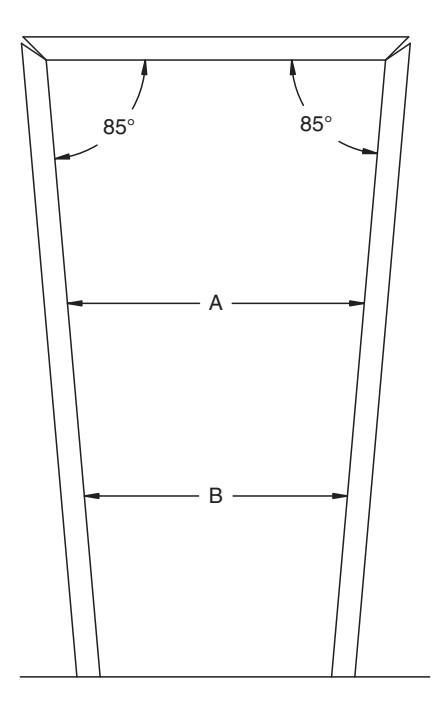
IMPROPERLY SET FRAME (B)

The corners are both greater than or less than 90°. The miters do not properly align with one another. When the corner is less than 90° the miter will have a gap which increases as it goes towards the return. When the corner is greater than 90° the miter will have a gap, which increases as it goes towards the rabbet. Dimensions taken at point "A" and "B" will not be equal. This condition will always result in dimension "B" being either greater than or less than the nominal opening dimension which would be obtained if checked between jambs along the header.

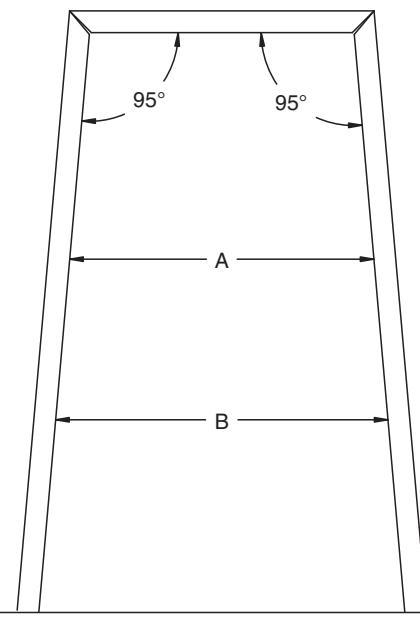
Jambs Toed Out at Sill

Jambs Toed In at Sill

To correct this condition, the sill anchors must be loosened to allow the bottom of each jamb to be moved in and/or out. In the case of the snap-in type sill anchor, the baseboard trim might have to be removed to gain access to the anchors. This type of anchor is generally used because it can be hidden by covering it with the baseboard trim.

If the jambs are toed in at the sills, the compression anchors might have to be retracted slightly so the sill (base) of the jambs can be pushed out. The jambs should be plumbed, squared with the header and leveled as they are pushed out into their proper position. The sill anchors should be reset, the compression anchors adjusted and retightened. The baseboard trim should be reattached to the wall if it had been removed.

A similar procedure should be used if the jambs are toed out at the sills. The sill (base) of the jambs should be pushed in towards the opening. The jambs should be plumbed, squared with the header and leveled as they are pushed into their proper position. The sill anchors should be reset, the compression anchors adjusted (extended) and retightened. The baseboard trim should be reattached to the wall if it had been removed.

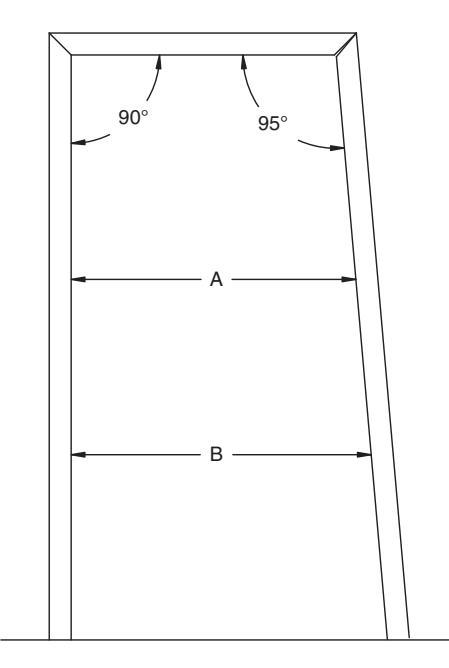
The jamb which is not 90° to the header must be moved. To correct this condition, the sill anchor must be loosened to allow the bottom of the jamb to be moved in or out as required. In the case of the snap-in type sill anchor, the baseboard trim may have to be removed to gain access to the anchor. This type of anchor is generally used because it can be hidden by covering it with the baseboard trim.

One Jamb Toed Out

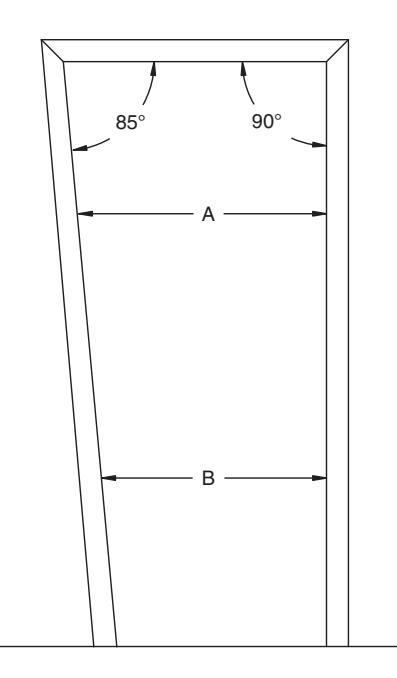
One Jamb Toed In

If the jamb is toed in at the sill, the compression anchor may have to be retracted slightly so the sill (base) of the jamb can be pushed out. The jamb should be plumbed, squared with the header and leveled as it is being pushed out into its proper position. The sill anchor should be reset, the compression anchor adjusted and retightened. The baseboard trim should be reattached to the wall if it had been removed.

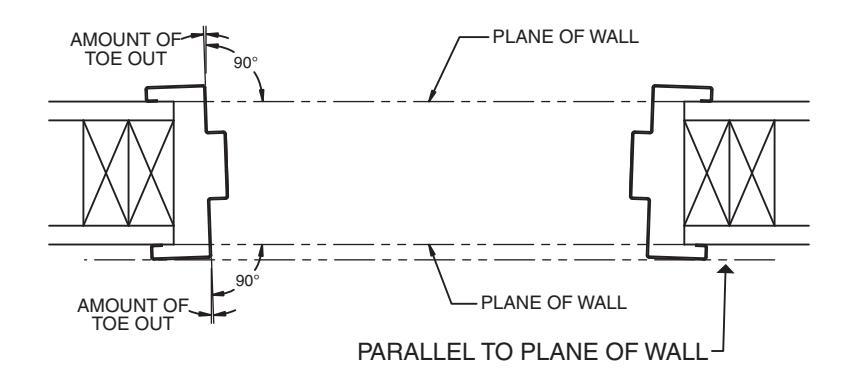
Typical toed-in or out condition

Note that the rabbet surfaces are not 90° to the plane of the wall. This can be checked by placing a straight edge across the face of both jambs.

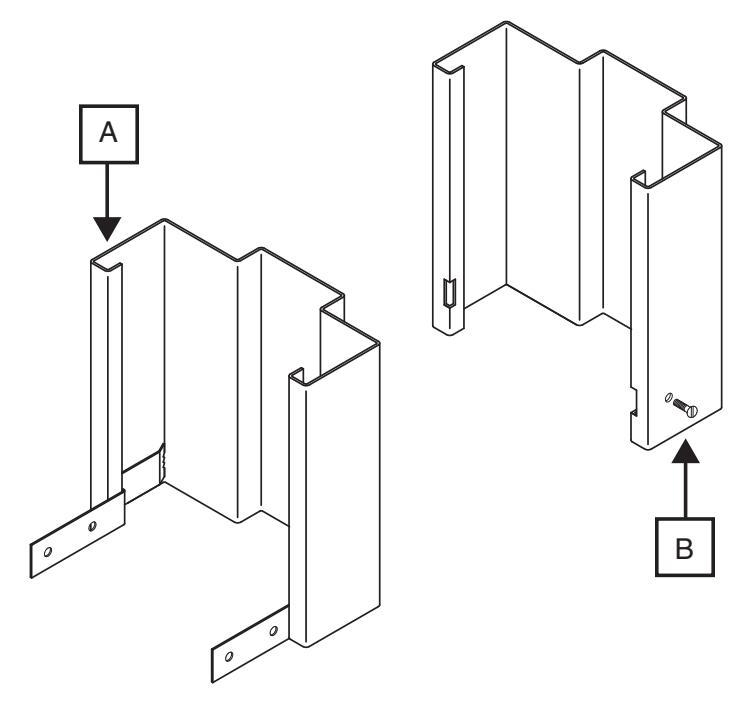
"A" shows an anchor which will be covered up by the baseboard trim. To gain access to this anchor the baseboard trim must first be removed. Next, the nails or screws holding the anchors to the wall must be removed. This will loosen the jamb and allow it to be squared in the opening.

"B" illustrates a screw going through the face of the frame into the wall. This holds the sill of the frame in position. This screw is exposed and is readily accessible. Removing the screw will loosen the jamb and allow it to be "squared-up" in the opening. If both jambs are toed in/out, they both should be "squared-up." This can be checked by taking measurements as shown

below. Both the "A" and "B" dimensions will be the same when the frames are properly set. However, the frame jambs must be plumb, level, and square with the head of the frame.

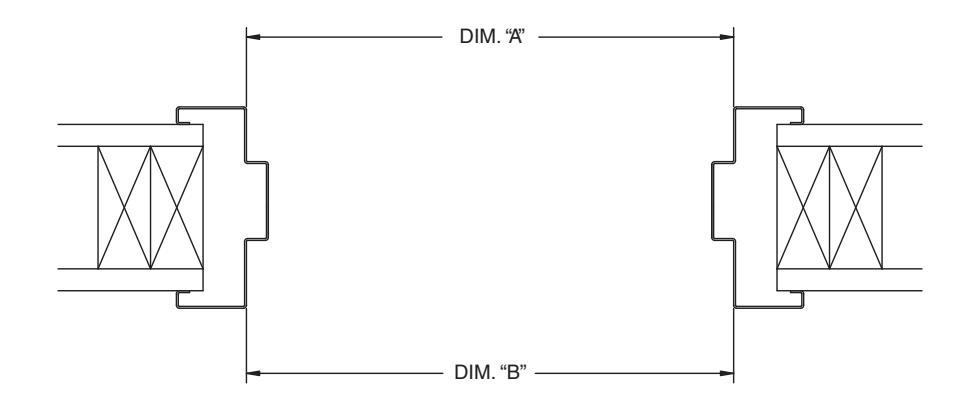
If both jambs are toed in/out, they both should be "squared-up." This can be checked by taking measurements as shown above. Both the "A" and "B" dimensions will be the same when the frames are properly set.

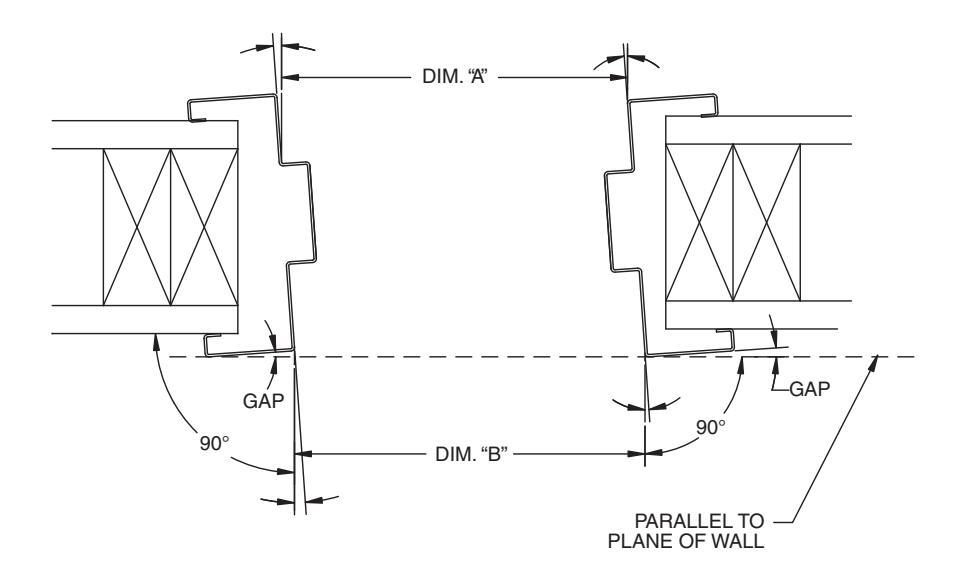
The below figure shows a condition which can give the impression that the frame is properly installed. Both dimensions "A" and "B" will be equal but the frame will not be square in the opening. Both jambs can be twisted to create a parallelogram. This can be checked by placing a straight edge across the face of both jambs (the straight edge is represented by the dotted line shown below). The straight edge should set flat across both faces at the same time. If the jambs are twisted, a "gap" will be created as shown in the illustration. The "gaps" will be to the same side if a parallelogram was created. The gaps could also be to opposite sides as shown in the Typical Toed In or Out Condition figure on the previous page.

This condition can be corrected as outlined for the other "toe out" or "toe in" examples.

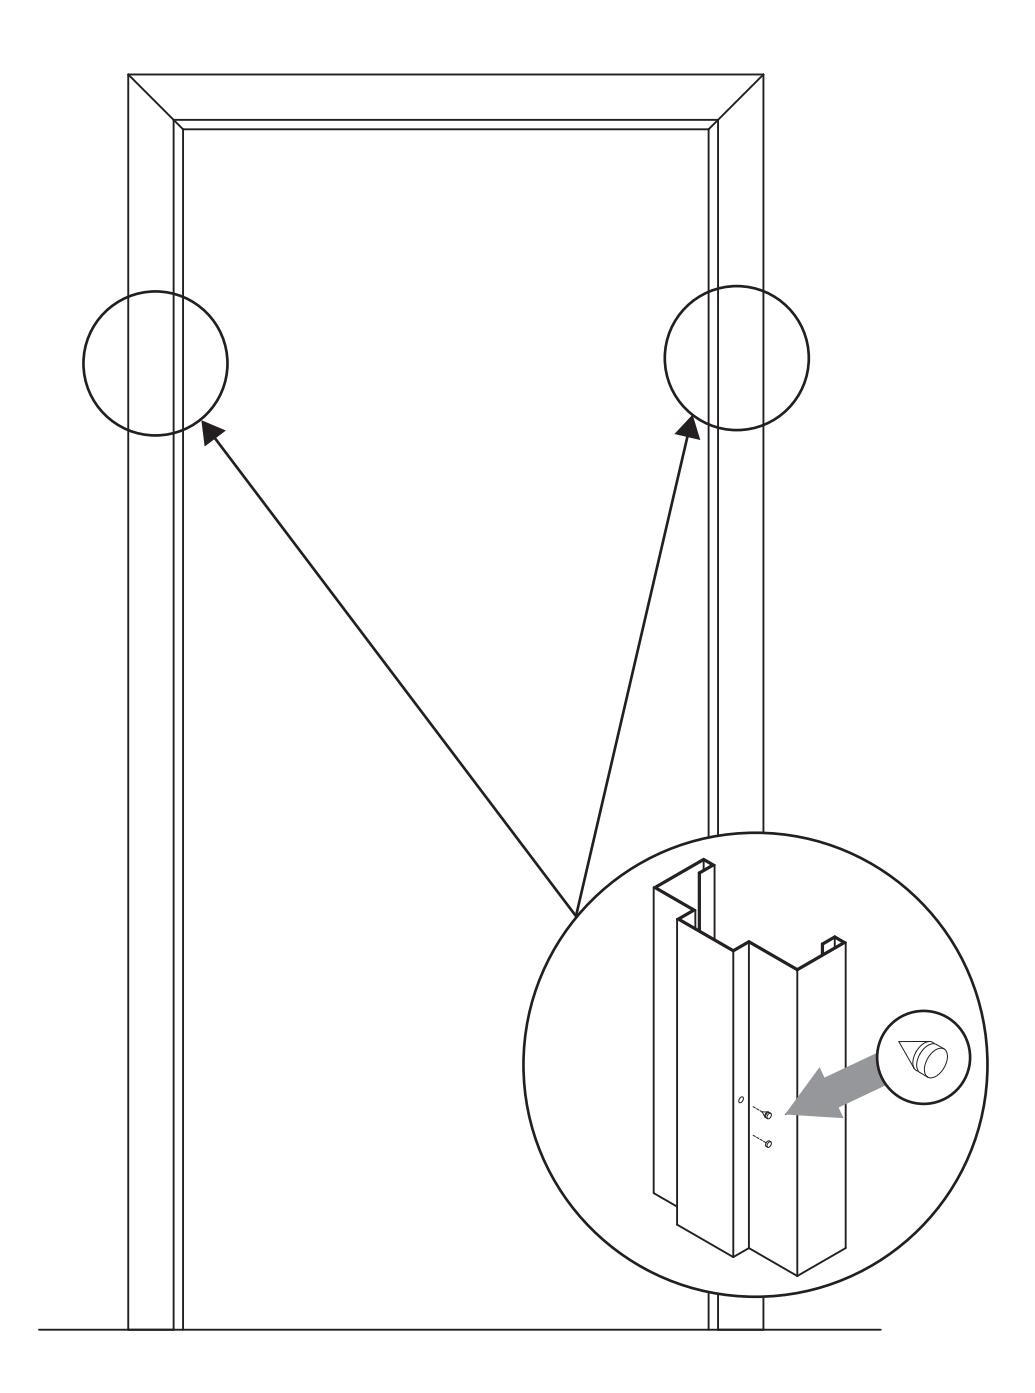
SILENCERS

Some manufacturers provide a silencer hole in the frame stop to accept a push-in silencer. A "stick-on" silencer is also available for application to frames without the silencer hole. The silencer acts as a "rubber bumper" which evenly holds the door off the stop at a constant distance. If the door is held off of the stop rather than being allowed to move slightly towards the stop, the latch tube will fit tighter into the strike. Three silencers are placed on the strike jamb, one toward the top of the jamb (nearer the header) and one toward the bottom of the jamb (nearer the sill) and the third near the strike preparation.

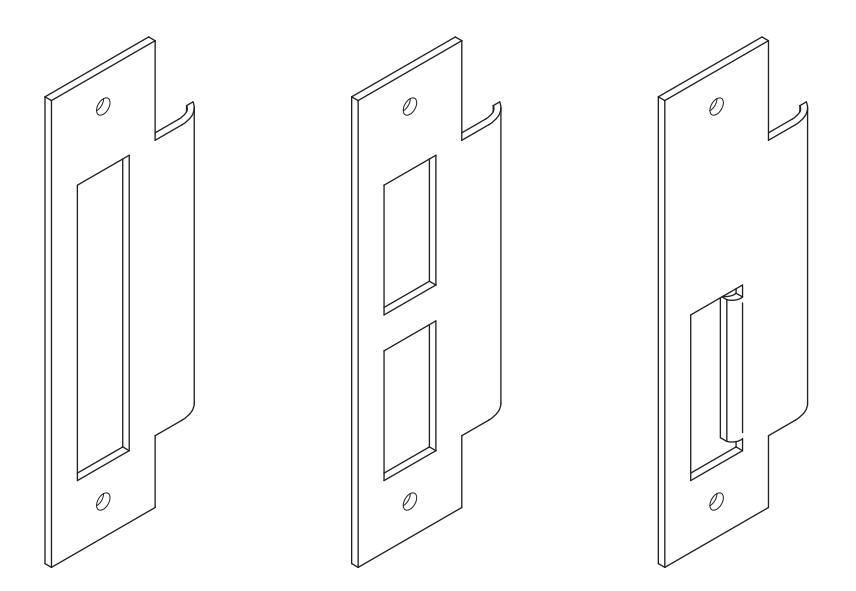
PROPER STRIKE

Is the proper strike plate attached to the frame?
