Installation Troubleshooting Guide for Standard Steel Doors and Frames

SDI-122 Installation Troubleshooting Guide for Standard Steel Doors and Frames

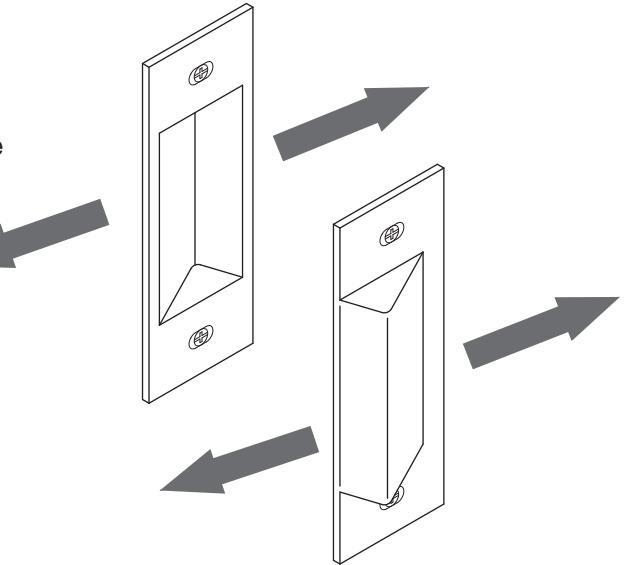
RIM EXIT DEVICES

An adjustable strike plate is provided. Is the strike plate properly adjusted to prove positive and secure latching?

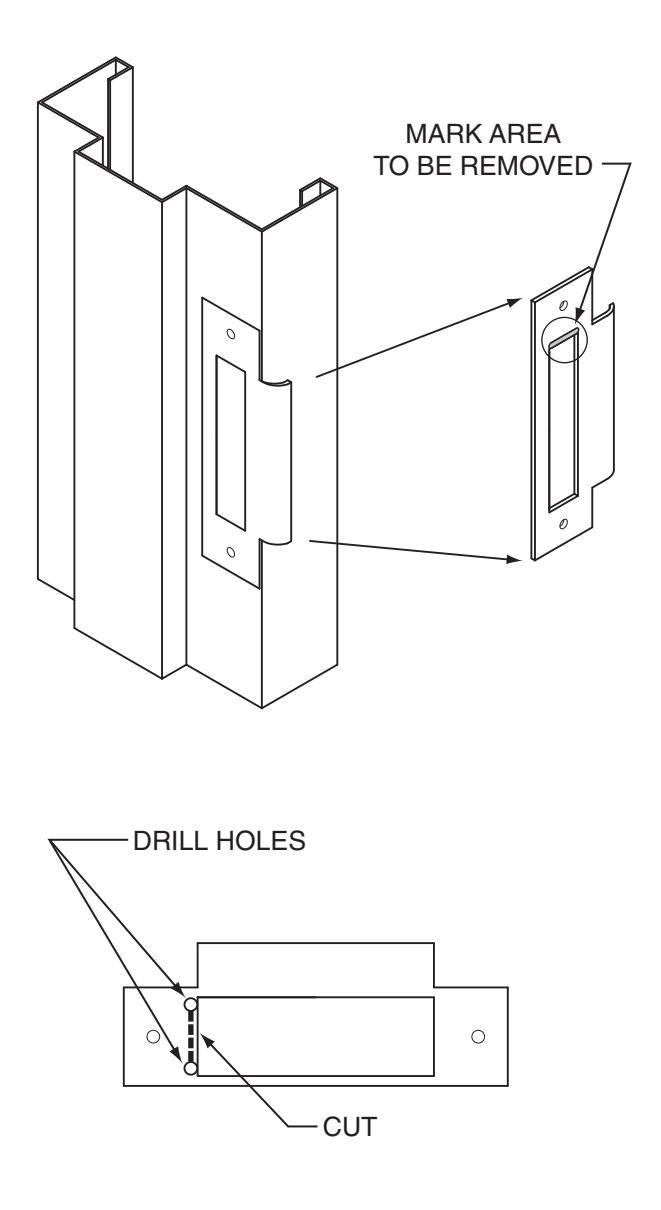
The previously mentioned items should be checked and any problems corrected. If the latch continues to tightly engage the strike, additional clearance can be created by filing the strike or bending the latch bolt lip as shown. However, this should only be done as a final option.

- Mark the area on the strike plate which must be removed.
- Remove strike plate from frame.
- Center punch corners of area to be removed and drill a 1/8" diameter hole in each corner.
- Use a saber saw and cut from the existing opening up to the ½" diameter holes. The remaining material between the two ½" holes should be filed away.
- Dress off all rough edges and corners with a file. This must be done since any irregular edges or edges with burrs could cause the latch tube to "drag" or "hang up" in the strike plate.
- Reassemble strike plate to frame and check alignment with lockset on door as well as latch tube function in and out of strike plate.

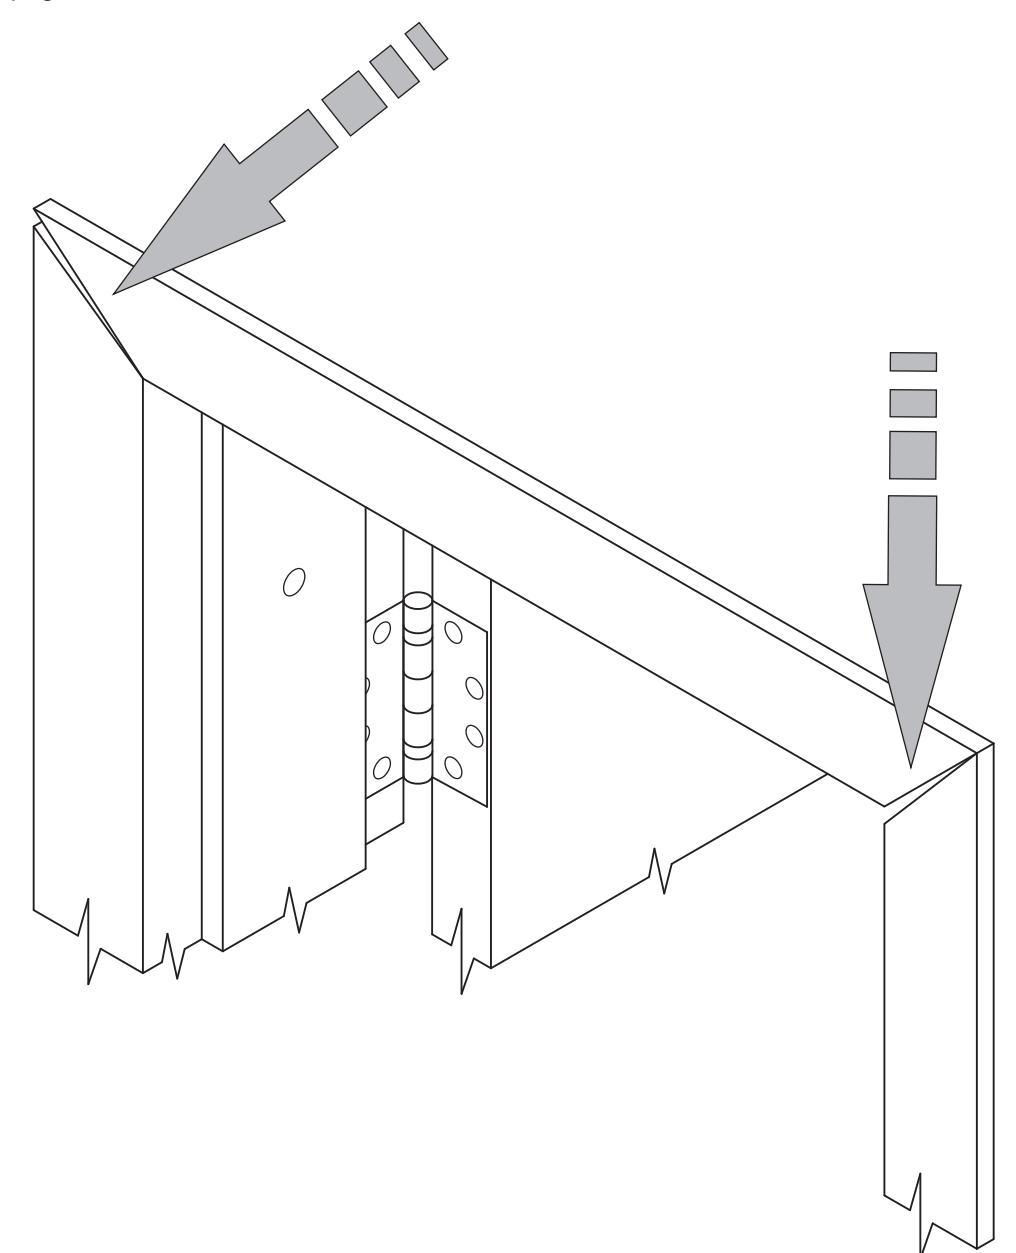
MITER NOT CLOSED ON FRAME

The major cause of miters not properly lining up and "closing" is incorrect installation. The effects of improper installation on miter seams are covered under the previous section of "Frame Set Out of Square." This section should be referenced for detailed explanations of conditions which could occur, and solutions for correcting the problems.

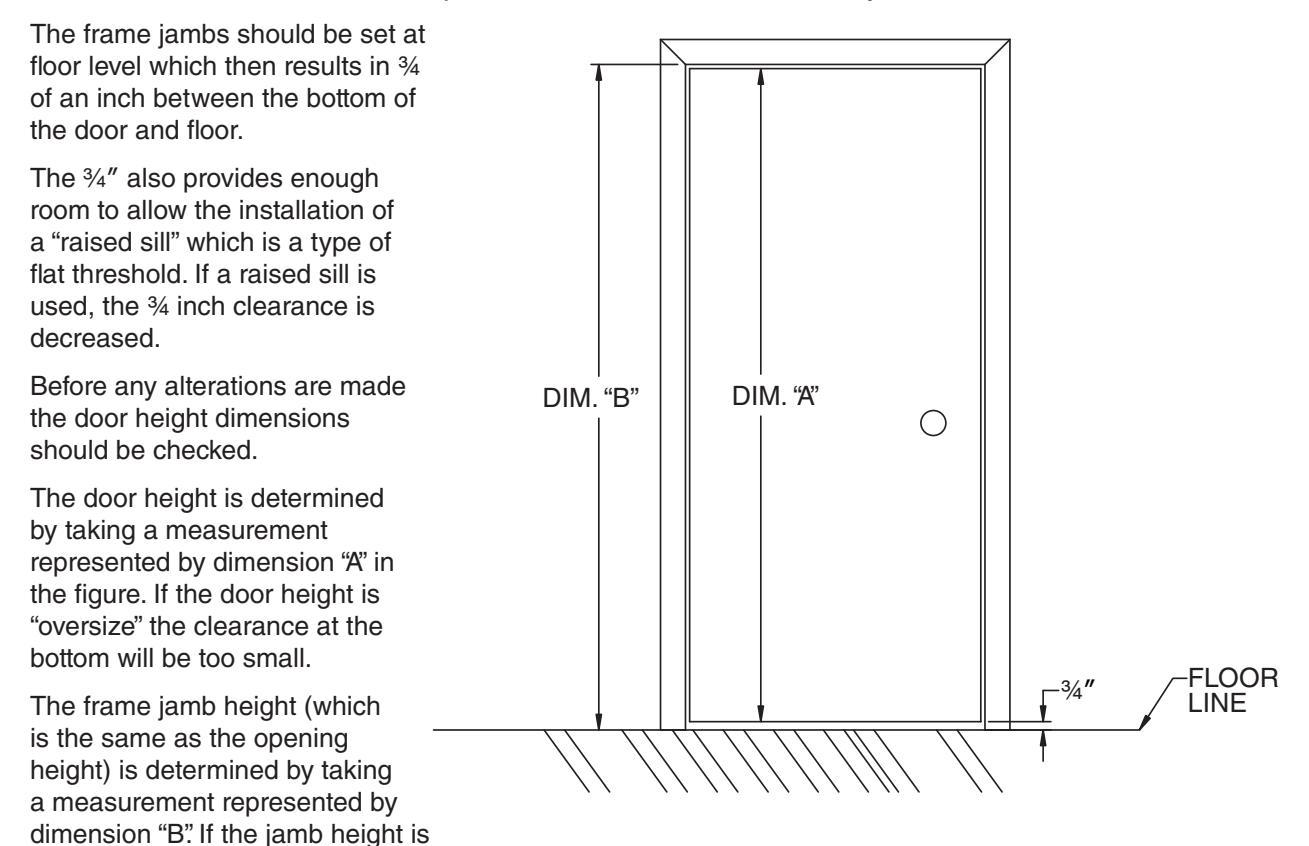
The available options for correcting this problem are limited. Frames which are permanently anchored to the wall construction (such as masonry or steel stud) leave few alternatives. The only available "fix" is to trim the bottom of the door, if the door's construction will permit trimming. As shown in the figure below, the nominal "sill clearance" should be $\frac{3}{4}$ of an inch. The sill clearance is the dimension from the bottom of the door to the bottom of the frame jambs, and $\frac{3}{4}$ " is a standard industry dimension.

"undersize," the clearance at the bottom will be too small.

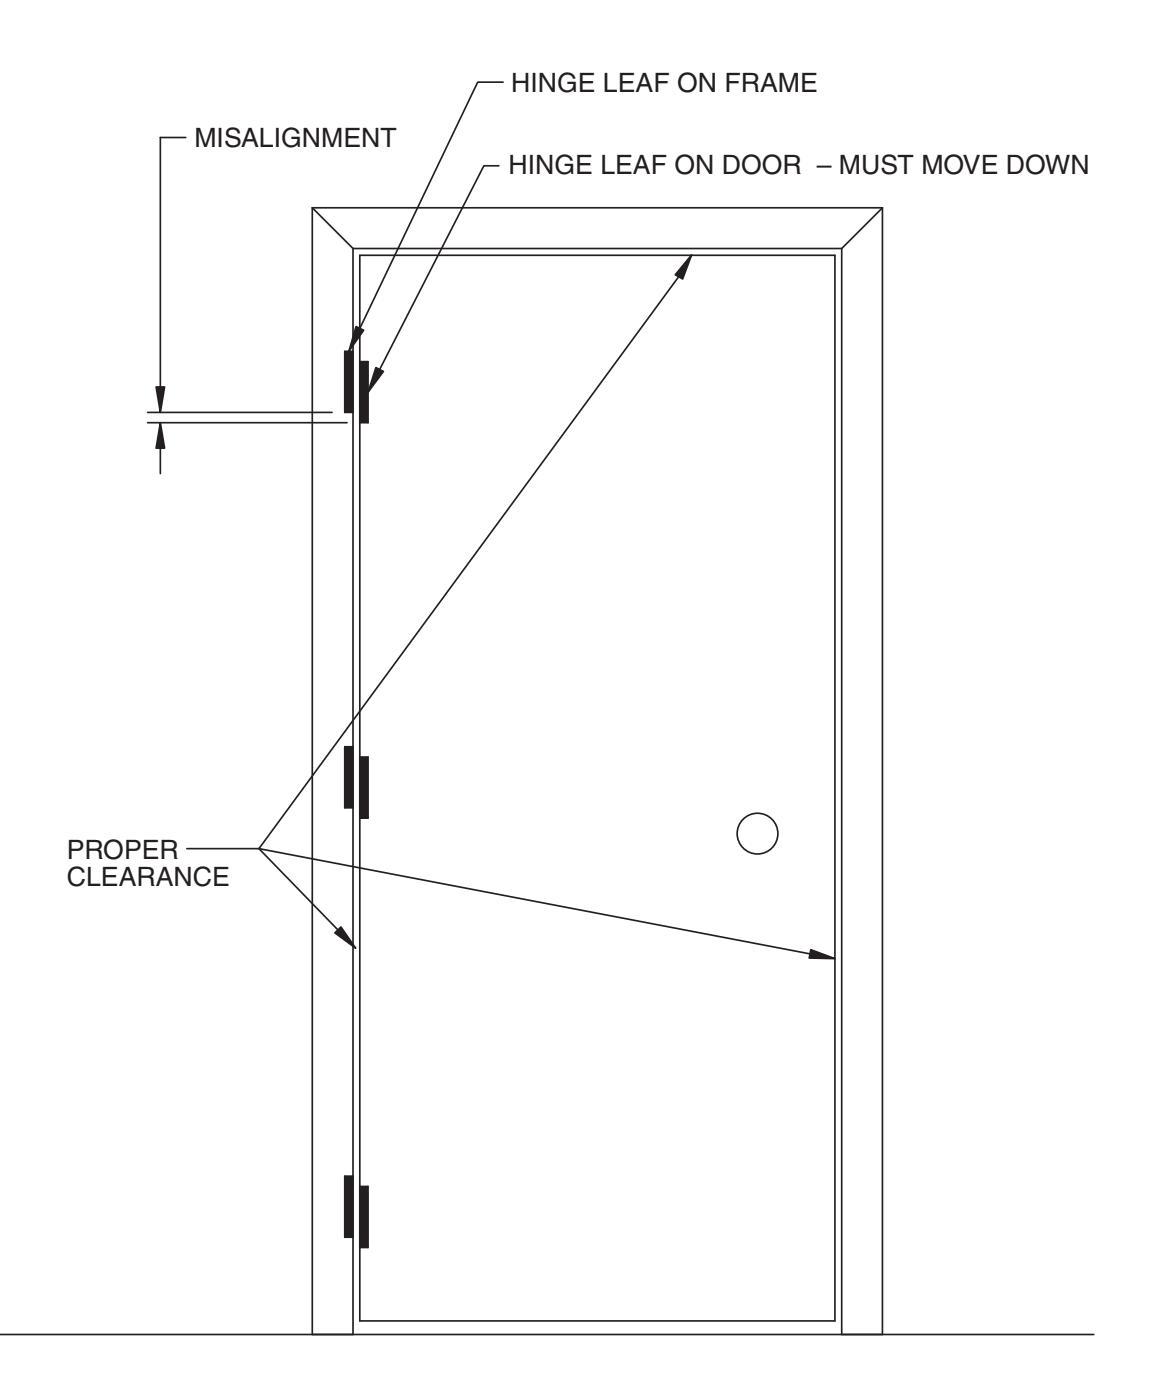
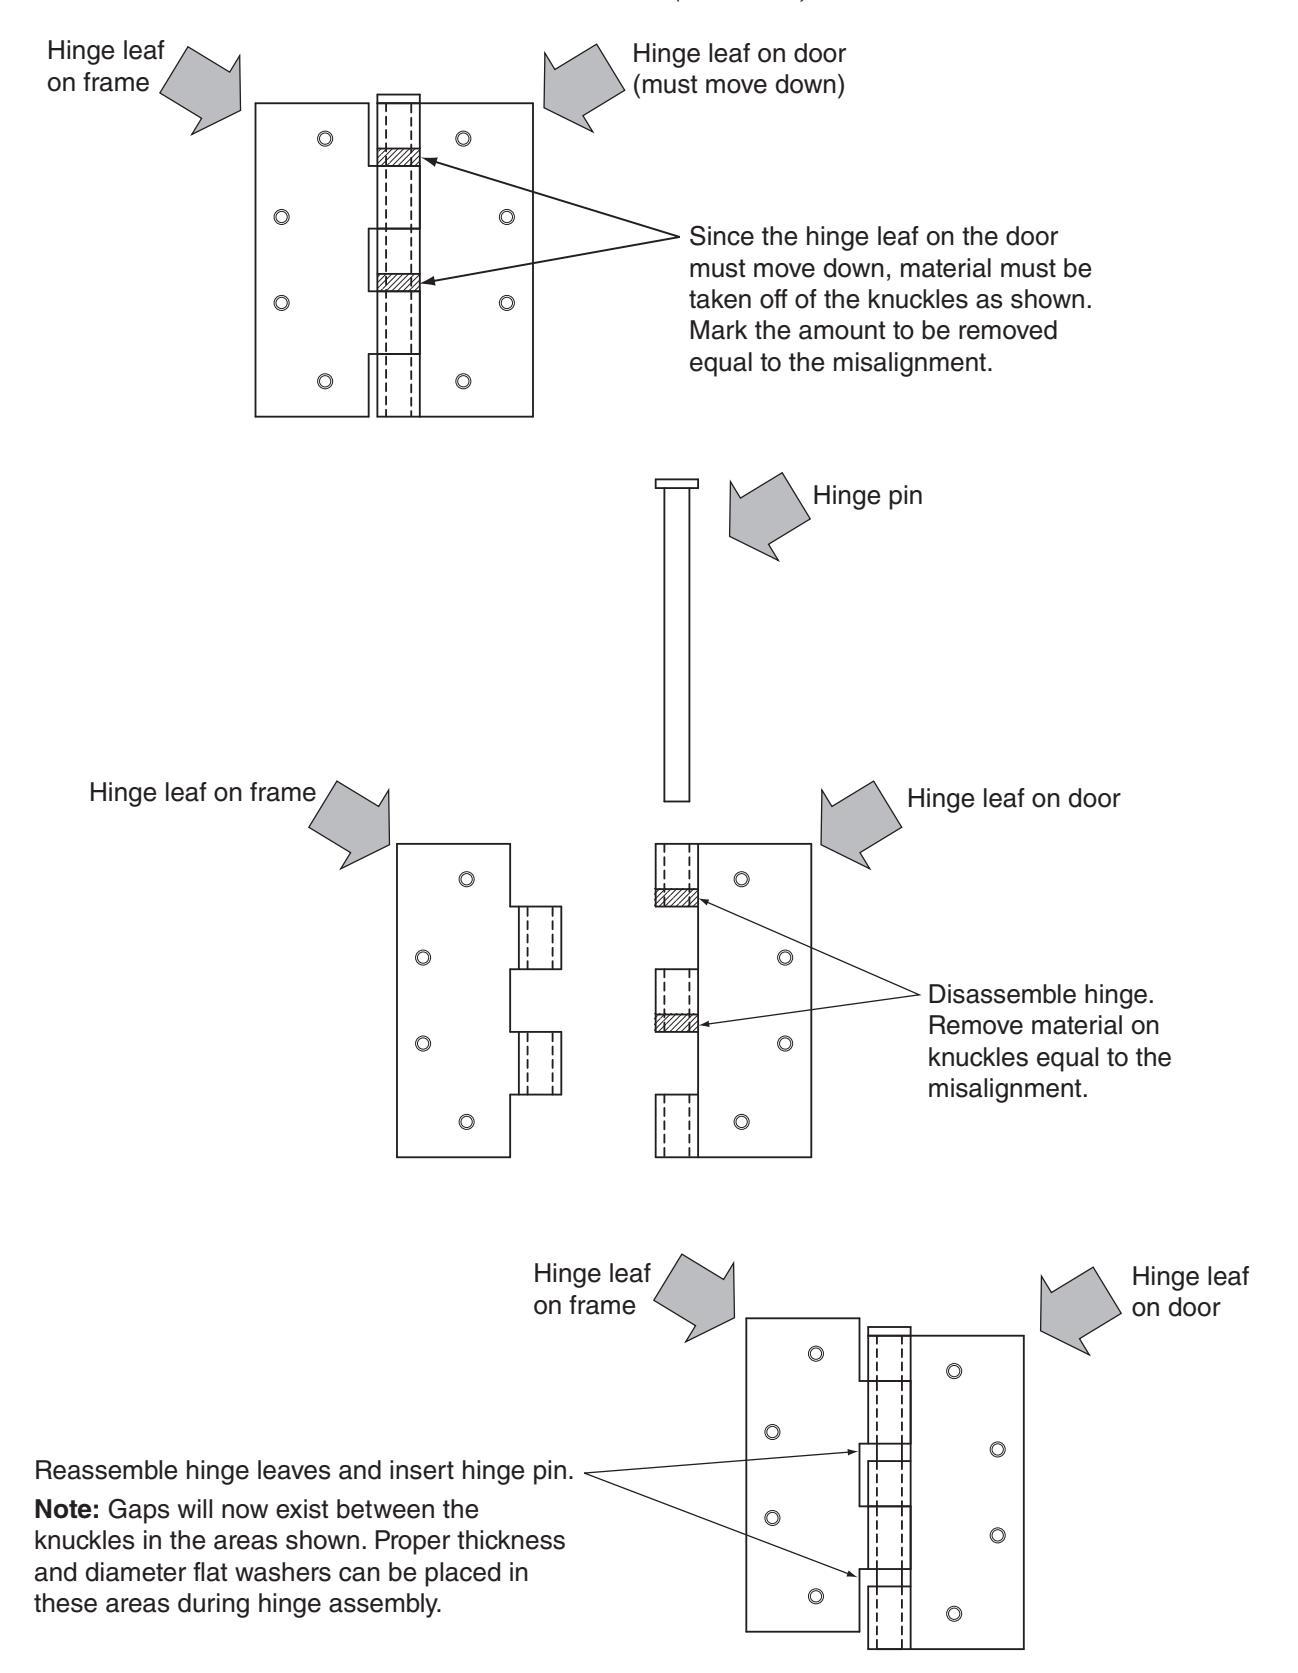
Frame and door hinge misalignment can cause a variety of problems. When misalignment occurs, either the door's hinge locations or frame's hinge locations are slightly off. This can apply to retrofitting existing openings where either the door or frame is being replaced, but not both. When new doors and frames are provided from a single manufacturer, this problem does not exist.

The example shown on the following page reflects the dropping of the hinge leaf which attaches to the door from its relationship to the hinge leaf on the frame. However, by removing material from the opposite end of the knuckles, the door hinge leaf could be raised as well. The frame hinge leaf can also be relocated in similar fashion.

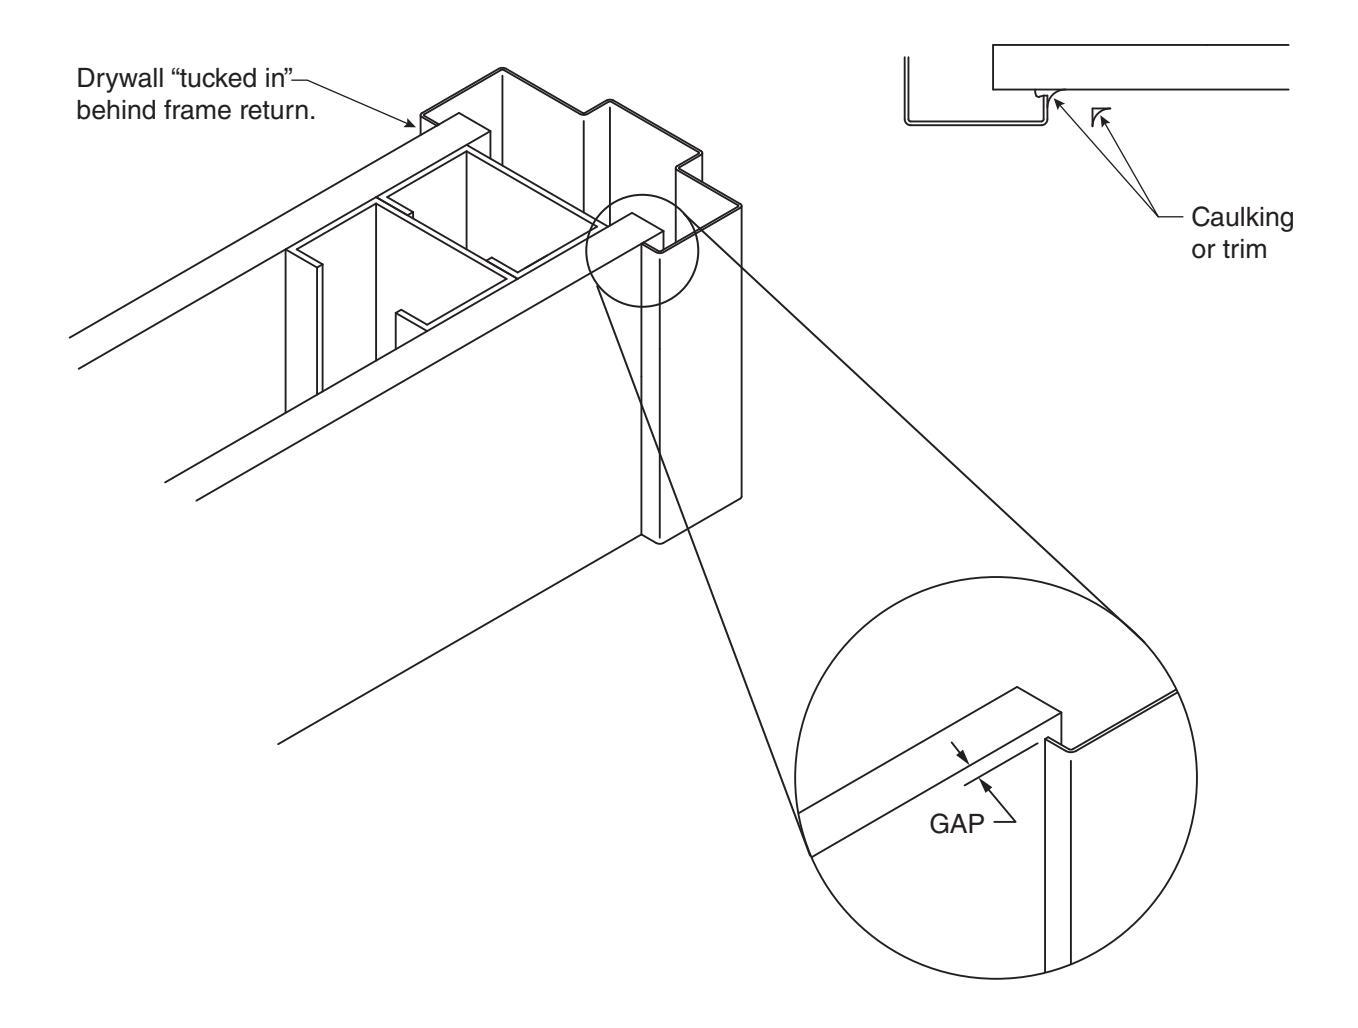
Some frames use welded or snapped-in steel or wood stud anchors. These frames are installed prior to the drywall material being attached to the studs. The drywall can either be "butted-up" against the return of the frame or be "tucked in" behind the return of the frame. Only in the installation where the drywall is "tucked in" behind the return can there be a condition where the frame is loose on the drywall. This gap could be uniform along the entire length (height) of the jamb or could be only in certain areas. Since the frame cannot be removed, the only available options are to caulk the gap or cover it with trim.

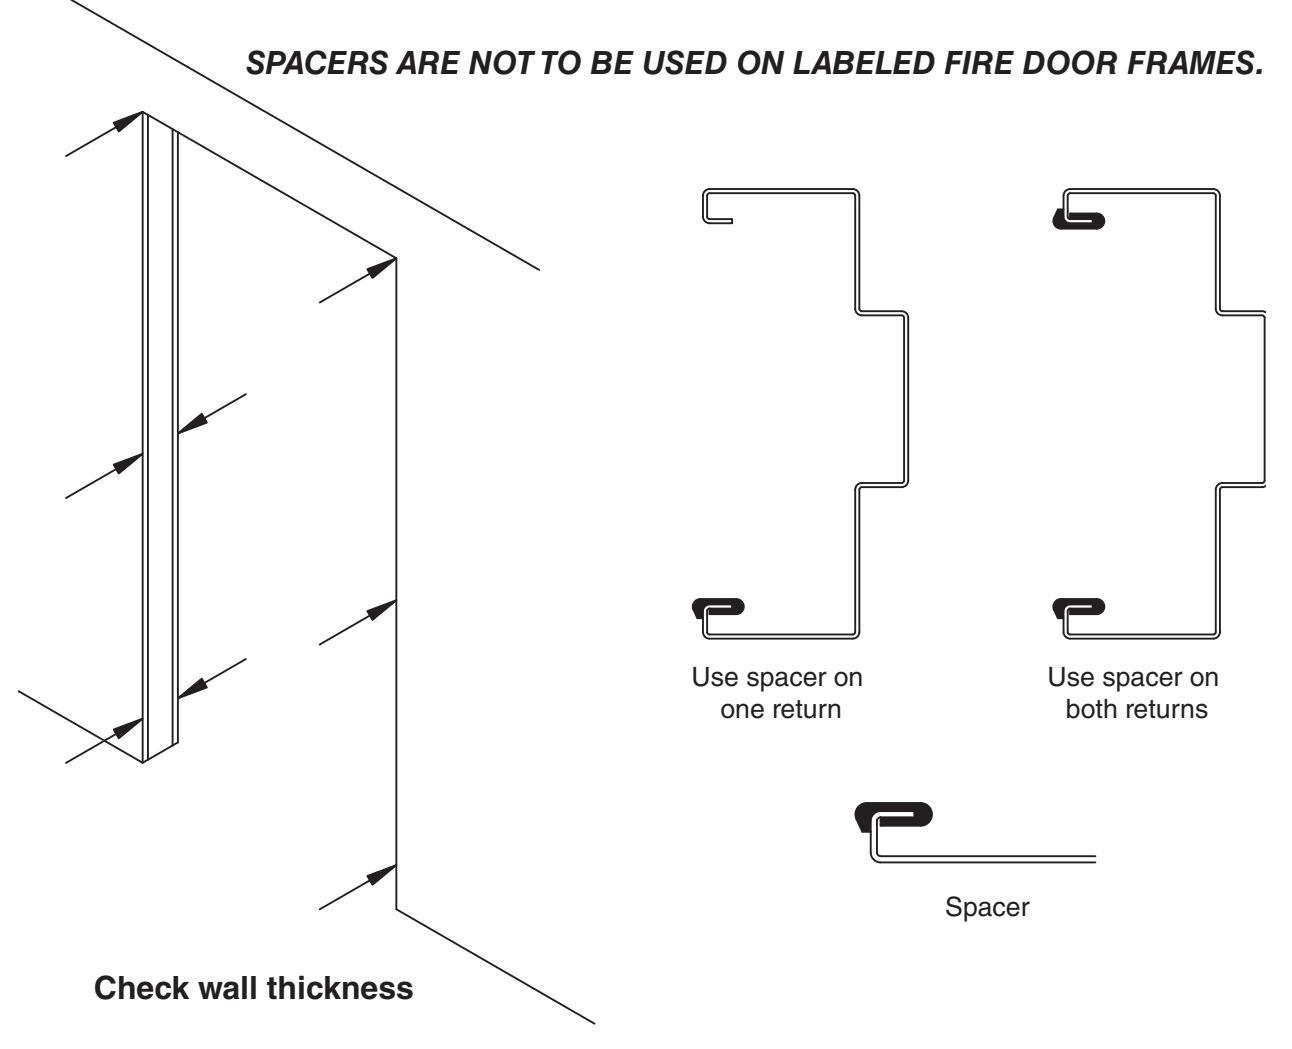
These frames are intended to be installed after the wall construction is complete. The anchoring methods that this type of frame uses allows the removal of the frame if so desired. The manufacturers' installation instructions should be followed anytime the frame is removed and reinstalled. Three conditions could exist for drywall slip-on frames which are "loose on the wall."

- The first condition is a uniform gap along the entire length (height) of the frame jambs. The frame should be removed from the opening and the wall thickness checked at numerous places around the opening. These measurements should be compared to the job specifications. If the wall thickness is undersize, two options are available.
 - a) If the gap is relatively small, the use of caulking or trim can be considered to cover the gap when the frame is installed.
 - b) If the gap is larger, the use of "spacers" can offset the lacking wall thickness. The use of spacers requires that the frame be removed from the opening, the spacer(s) attached, and the frame reinstalled. The spacers can be used on either one or both of the frame returns which would result in spacers on either one side or both sides of the wall. Spacers are available from the frame manufacturer.

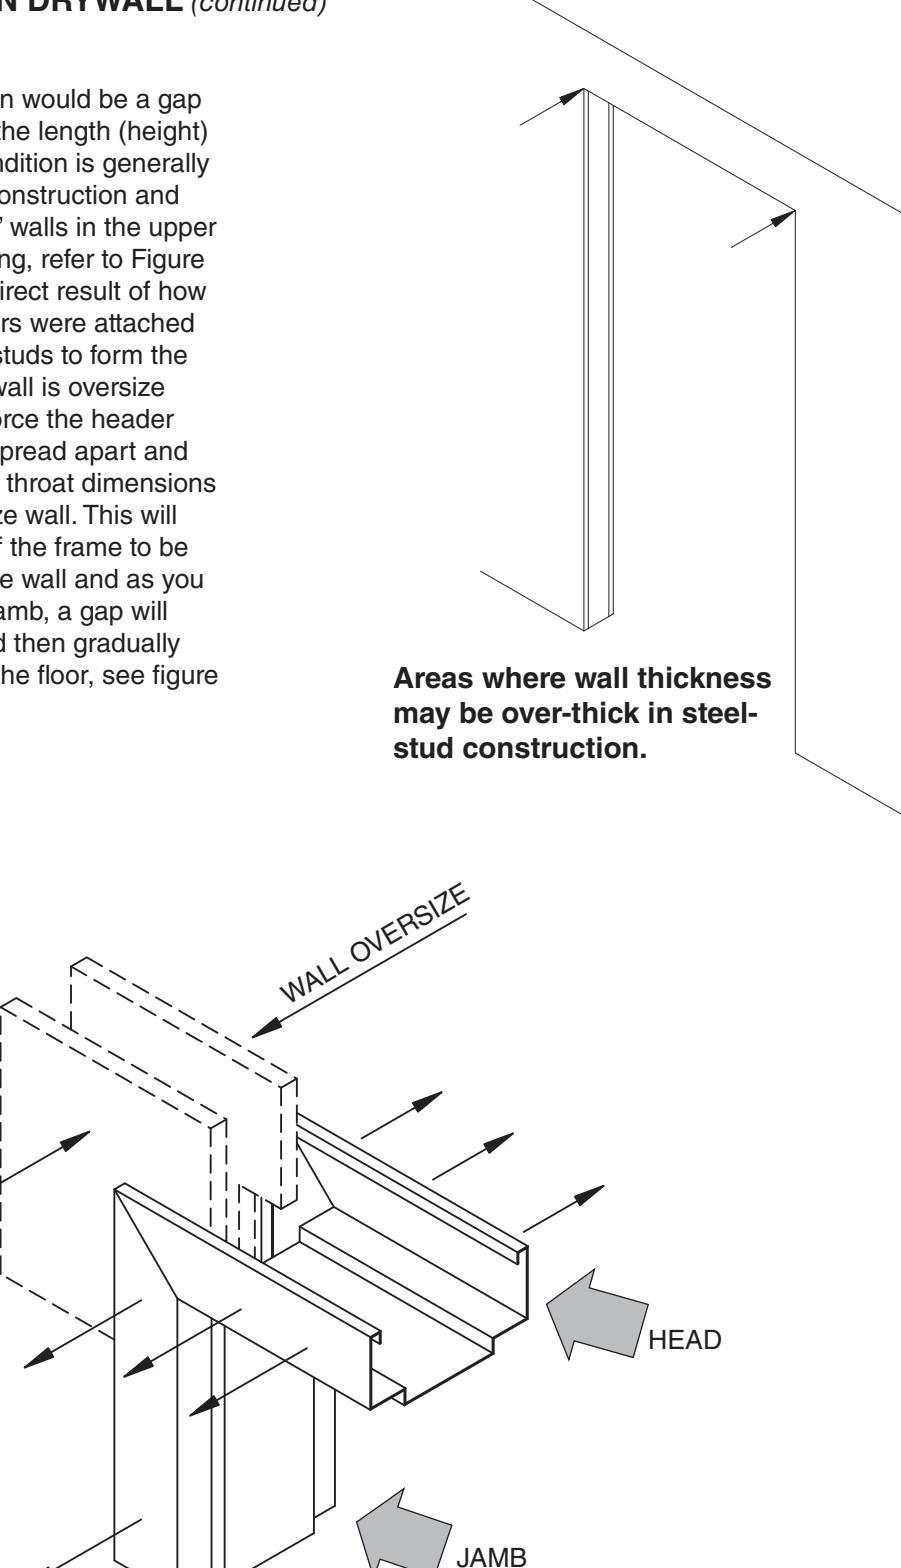
Frame spreads apart with oversize wall.

2) The second condition would be a gap that changes along the length (height) of the jamb. This condition is generally found in steel stud construction and results in "over thick" walls in the upper corners of the opening, refer to Figure 5. This is usually a direct result of how the steel stud headers were attached to the vertical steel studs to form the opening. When the wall is oversize (in this area) it will force the header and jamb miters to spread apart and actually open up the throat dimensions to accept the oversize wall. This will cause the corners of the frame to be extremely tight on the wall and as you progress down the jamb, a gap will begin to develop and then gradually disappear closer to the floor, see figure on following page.

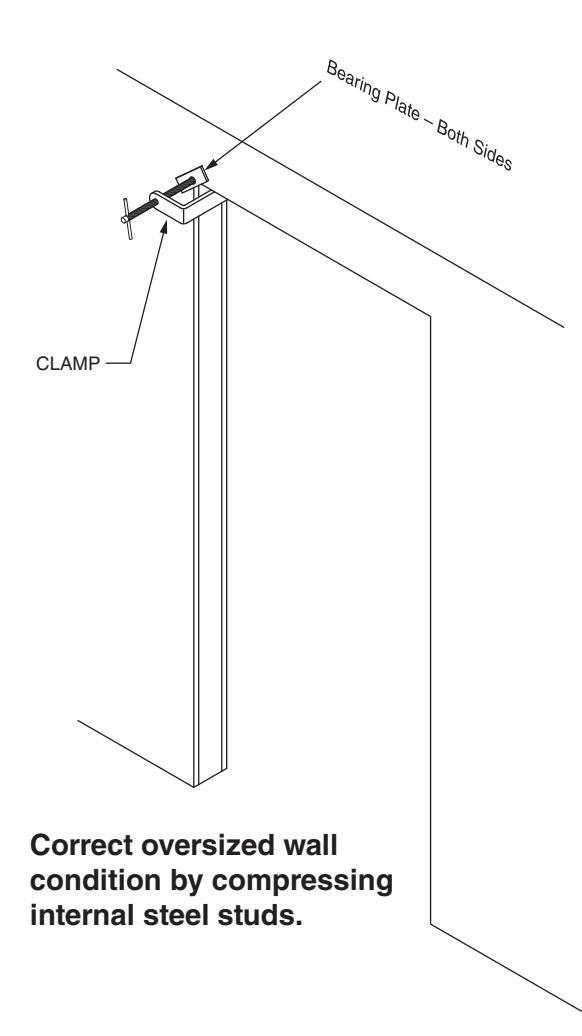
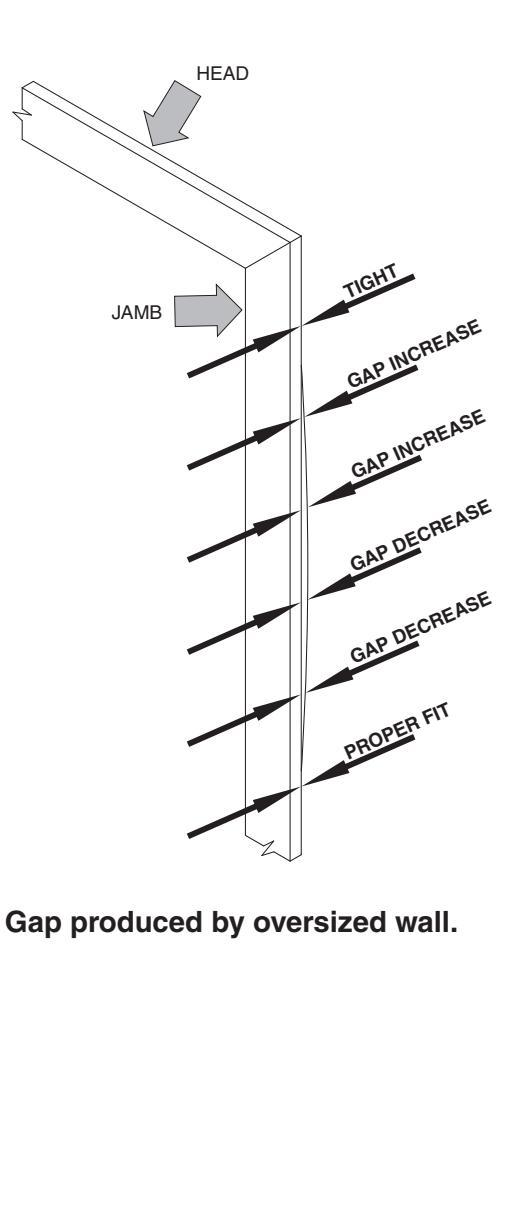
This condition should be reported to the appropriate jobsite personnel. The condition can be corrected by putting a bearing plate on each side of the corner and compressing the internal steel studs with a clamp. However, the responsibility for correcting this condition belongs to the sub-contractor responsible for the actual wall construction.

3) The third condition is different from the first two which address the "fit" of the frame over the wall thickness. The cause of this condition is compression anchors which have not been tightened. The drywall frame would then be loose across the width of the opening and move from side to side against the rough opening.

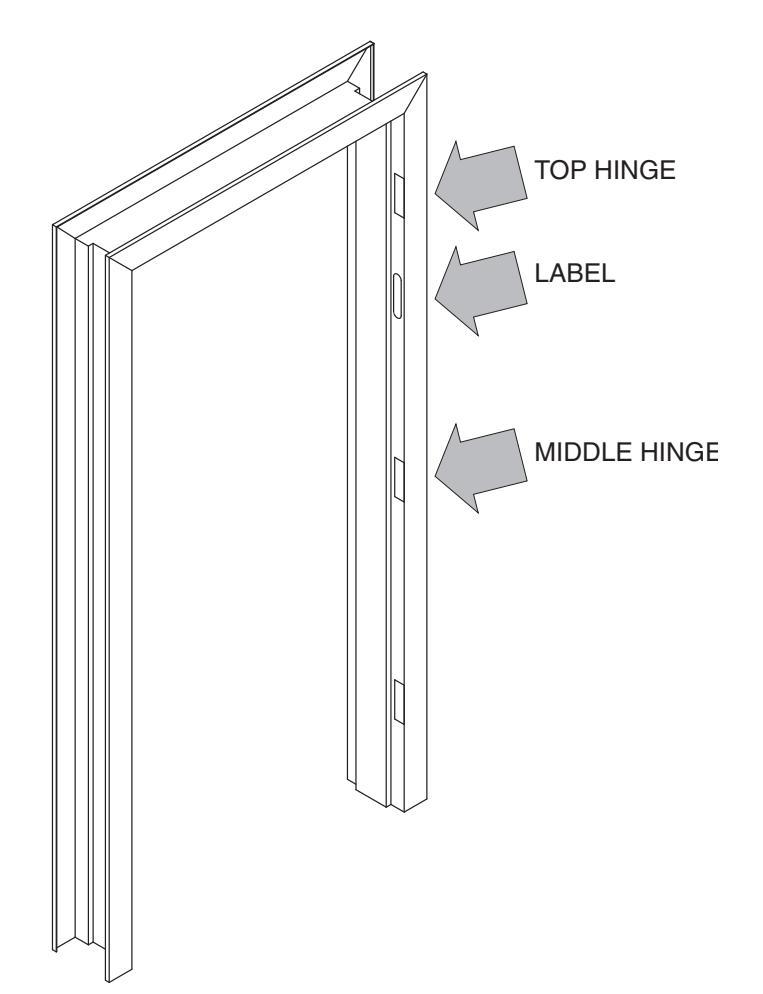
All labels on fire rated frames are located on the hinge jamb between the top and middle hinge (see figure below). It should be noted that some frames have an embossed label, rather than a surface-attached label. The embossed label is stamped into the frame rabbet and can be painted over.

If the label or embossment is not present, the frame distributor should be contacted.

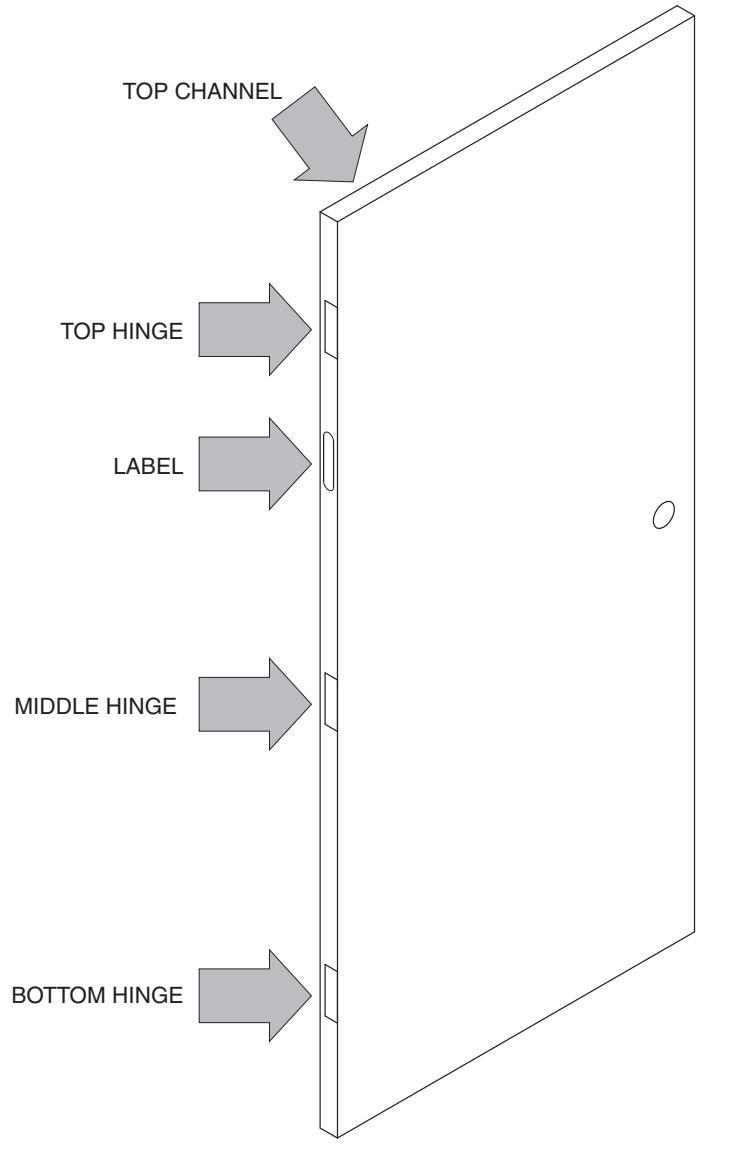
LABEL MISSING FROM FIRE-RATED DOOR

If the label is not present, the door distributor should be contacted.

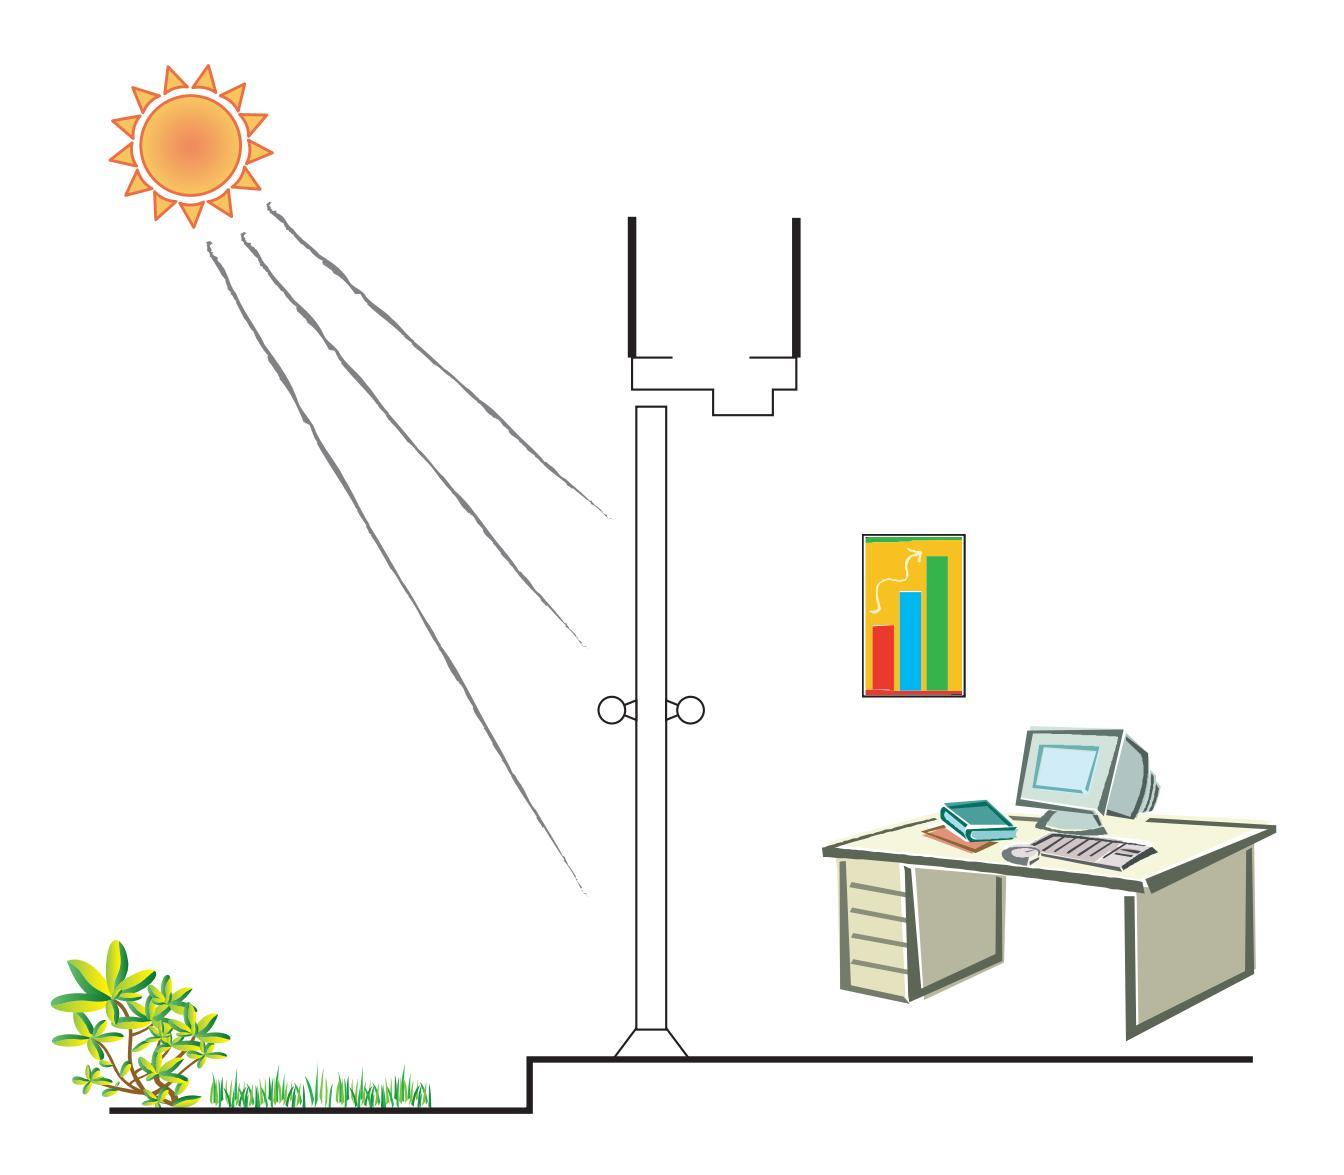
Installers need to be aware of a condition known as Thermal Bow. Thermal Bow is a temporary condition which may occur in metal doors due to the inside-outside temperature differential. This is more common when the direct rays of the sun are on a door surface. This condition is temporary, and to a great extent depends on the door color, door construction, length of exposure, temperature, etc. This condition can often be alleviated by painting the exposed surface a light color. Thermal bow can occur in reverse under extremely cold conditions. Typical symptoms of thermal bow are hardware latching difficulty and door clearance issues.
